## Access Compliance Report Public Rights-of-Way (Curb Ramps)

Intersection ID: N/AMain Street:PAUL\_BUCK\_BVCross Street: N/ALocation:SWADA ID: 5E47810BD965Ramp Type:MedianPerpInitial Pass/Fail:FailOverall Compliance: NoSeverity Score:12.5

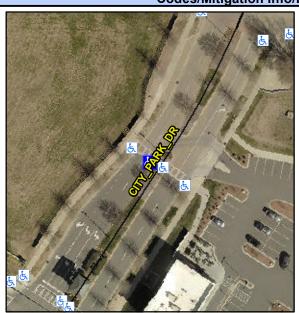
Field Measurements/Component Compliance							
Comp	liance Description	Data	Comp	liance	Description	Data	
N/A	Ramp Length (in)	40.0	No	Ramp	Slope (%)	9.8	
Yes	Ramp Width (in)	48.0	Yes	Ramp	XSlope (%)	1.0	
N/A	Flare Type LT	N/A	N/A	Flare	Type RT	N/A	
N/A	Flare Slope LT (%)	N/A	N/A	Flare	Slope RT (%)	N/A	
N/A	Flare Traversable LT?	N/A	N/A	Flare	Traversable RT?	N/A	
N/A	Landing Length (in)	N/A	N/A	DWS	Provided?	N/A	
N/A	Landing Width (in)	N/A	N/A	DWS	Contrast?	N/A	
N/A	Landing Slope (%)	N/A	N/A	DWS	Length (in)	N/A	
N/A	Landing X Slope (%)	N/A	N/A	DWS	Full Width?	N/A	
N/A	Landing Curb? (Y/N)	N/A	N/A	DWS	Offset (in)	N/A	
N/A	Shared Landing?	N/A					
N/A	Gutter Ponding?	N/A	N/A	Gutte	r Slope (%)	N/A	
N/A	Gutter Lip Ht (in)	N/A	N/A	Gutte	r X Slope (%)	N/A	
N/A	Painted X Walk1?	Yes	N/A	Painte	ed X Walk2?	N/A	
	X Walk 1 Direction	To NW		X Wal	k 2 Direction	N/A	
N/A	X Walk 1 Width (in)	91.0	N/A	X Wal	k 2 Width (in)	N/A

X Walk 1 Slope (%)	3.0		X Wal	k 2 Slope (%)	N/A	
	X Walk 1 X Slope (%)	0.4		X Wal	k 2 X Slope (%)	N/A	
N/A	Ramp inside XWalk1?	Yes	N/A	Ramp	inside XWalk2?	N/A	
	Road Slope (%)	N/A	N/A	Clear	Space?	N/A	
	Road X Slope (%)	N/A	N/A	Clear	Space to XWalk (in)	N/A	
N/A	Any Obstructions?	N/A	N/A	Storm	Grate/Utility Hazard?	N/A	
	Obstruction Type			Storm	Grate/Utility Type		
		N/A				N/A	
			Yes	Surfac	ce Condition? (G/P)	Good

Possible Solutions:	9
Remove & Replace Entire Ramp.	N
•	Y
	N
	N
	N
	N
Surveyor Notes:	N
N/A	N
	N
	N
	N
PROW/ADA:	N
Not Found, R304.2.2	N
	N
	N
	N

1650.00
