# Access Compliance Report

## Public Rights-of-Way

### (Curb Ramps)

Intersection ID: 7252	Main Street: CEDARHURST_DR	Cross Street: DALECREST_DR	Location: NE
ADA ID: 5E5D39DB1C1E	Ramp Type: Perp	Initial Pass/Fail: Fail	Overall Compliance: No
Severity Score: 26.25			
Codes/Mitigation Info/Possible Solution		Field Measurements/Component Compliance

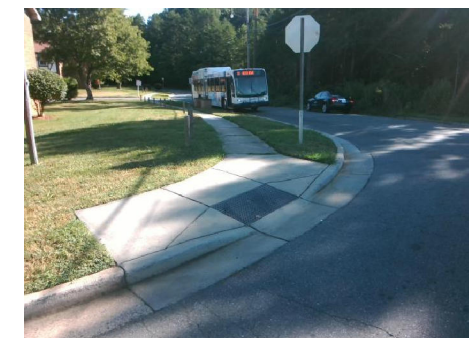
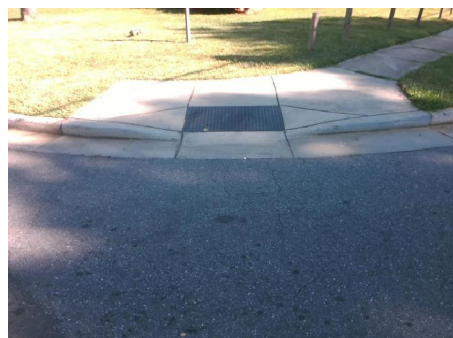
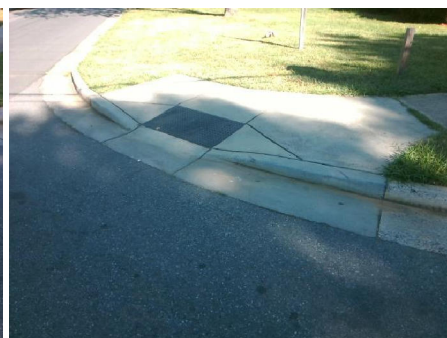
Compliance	Description	Data	Compliance	Description	Data
N/A	Ramp Length (in)	66.0	No	Ramp Slope (%)	12.9
Yes	Ramp Width (in)	48.0	Yes	Ramp XSlope (%)	4.4
N/A	Flare Type LT	N/A	N/A	Flare Type RT	N/A
N/A	Flare Slope LT (%)	N/A	N/A	Flare Slope RT (%)	N/A
N/A	Flare Traversable LT?	N/A	N/A	Flare Traversable RT?	N/A
N/A	Landing Length (in)	N/A	N/A	DWS Provided?	N/A
N/A	Landing Width (in)	N/A	N/A	DWS Contrast?	N/A
N/A	Landing Slope (%)	N/A	N/A	DWS Length (in)	N/A
N/A	Landing X Slope (%)	N/A	N/A	DWS Full Width?	N/A
N/A	Landing Curb? (Y/N)	N/A	N/A	DWS Offset (in)	N/A
N/A	Shared Landing?	N/A			
N/A	Gutter Ponding?	N/A	N/A	Gutter Slope (%)	N/A
N/A	Gutter Lip Ht (in)	N/A	N/A	Gutter X Slope (%)	N/A
N/A	Painted X Walk1?	No	N/A	Painted X Walk2?	N/A
	X Walk 1 Direction	To S		X Walk 2 Direction	N/A
N/A	X Walk 1 Width (in)	N/A	N/A	X Walk 2 Width (in)	N/A
	X Walk 1 Slope (%)	2.5		X Walk 2 Slope (%)	N/A
	X Walk 1 X Slope (%)	7.2		X Walk 2 X Slope (%)	N/A

N/A	Ramp inside XWalk1?	N/A	N/A	Ramp inside XWalk2?	N/A
	Road Slope (%)	N/A	N/A	Clear Space?	N/A
	Road X Slope (%)	N/A	N/A	Clear Space to XWalk (in)	N/A
N/A	Any Obstructions?	N/A	N/A	Storm Grate/Utility Hazard?	N/A
	Obstruction Type			Storm Grate/Utility Type	
		N/A			N/A
			Yes	Surface Condition? (G/P)	Good

**Remove & Replace Entire Ramp.**

**Not Found, R304.2.2**
