Access Compliance Report

Public Rights-of-Way

(Curb Ramps)

Intersection ID: 11671	Main Street: PARKWOOD_AV	Cross Street: N_CALDWELL_ST	Location: S
ADA ID: 5E5F9AB22193	Ramp Type: IslandPerp	Initial Pass/Fail: Fail	Overall Compliance: No
Severity Score: 22.5			
Codes/Mitigation Info/Possible Solution		Field Measurements/Component Compliance

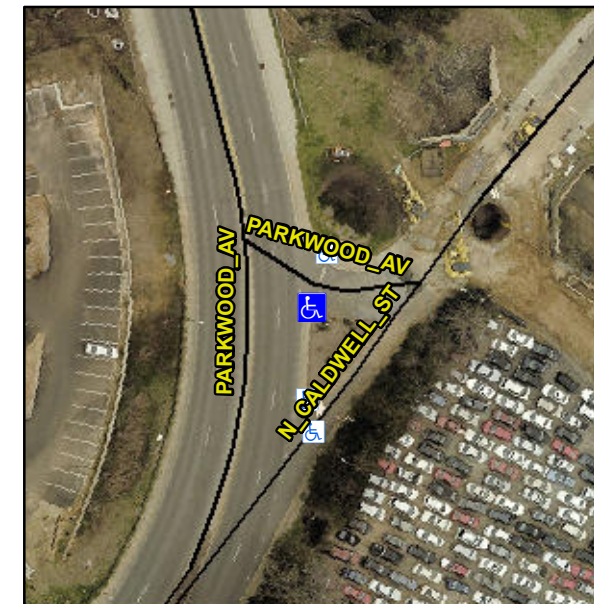
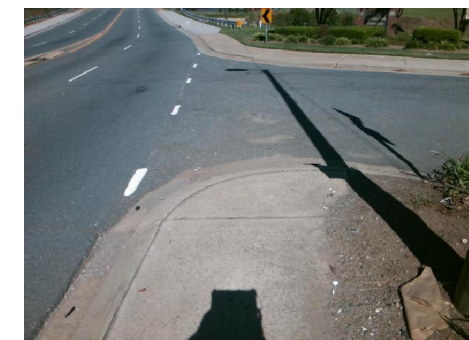
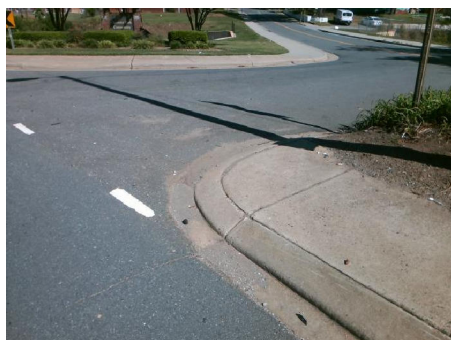
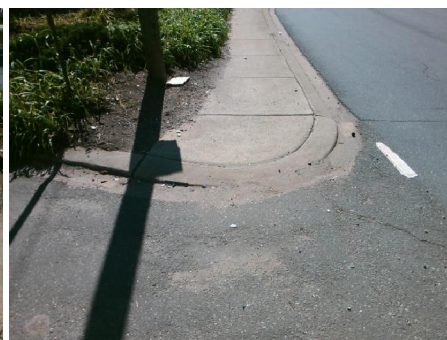
Not Found, R304.5.1, R304.2.2, R304.5.3

Compliance	Description	Data	Compliance	Description	Data
N/A	Ramp Length (in)	42.0	No	Ramp Slope (%)	8.4
No	Ramp Width (in)	40.0	No	Ramp XSlope (%)	3.6
N/A	Flare Type LT	N/A	N/A	Flare Type RT	N/A
N/A	Flare Slope LT (%)	N/A	N/A	Flare Slope RT (%)	N/A
N/A	Flare Traversable LT?	N/A	N/A	Flare Traversable RT?	N/A
N/A	Landing Length (in)	N/A	N/A	DWS Provided?	N/A
N/A	Landing Width (in)	N/A	N/A	DWS Contrast?	N/A
N/A	Landing Slope (%)	N/A	N/A	DWS Length (in)	N/A
N/A	Landing X Slope (%)	N/A	N/A	DWS Full Width?	N/A
N/A	Landing Curb? (Y/N)	N/A	N/A	DWS Offset (in)	N/A
N/A	Shared Landing?	N/A			
N/A	Gutter Ponding?	N/A	N/A	Gutter Slope (%)	N/A
N/A	Gutter Lip Ht (in)	N/A	N/A	Gutter X Slope (%)	N/A
N/A	Painted X Walk1?	No	N/A	Painted X Walk2?	N/A
	X Walk 1 Direction	To N		X Walk 2 Direction	N/A
N/A	X Walk 1 Width (in)	N/A	N/A	X Walk 2 Width (in)	N/A
	X Walk 1 Slope (%)	4.5		X Walk 2 Slope (%)	N/A
	X Walk 1 X Slope (%)	0.7		X Walk 2 X Slope (%)	N/A

N/A	Ramp inside XWalk1?	N/A	N/A	Ramp inside XWalk2?	N/A
	Road Slope (%)	N/A	N/A	Clear Space?	N/A
	Road X Slope (%)	N/A	N/A	Clear Space to XWalk (in)	N/A
N/A	Any Obstructions?	N/A	N/A	Storm Grate/Utility Hazard?	N/A
	Obstruction Type			Storm Grate/Utility Type	
		N/A			N/A
			Yes	Surface Condition? (G/P)	Good

Remove & Replace Entire Ramp.
