# Access Compliance Report

## Public Rights-of-Way

### (Curb Ramps)

| Intersection ID: 29795 | Main Street: BRISTLE_TOE_LN | Cross Street: CHELTON_RIDGE_LN | Location: NE |

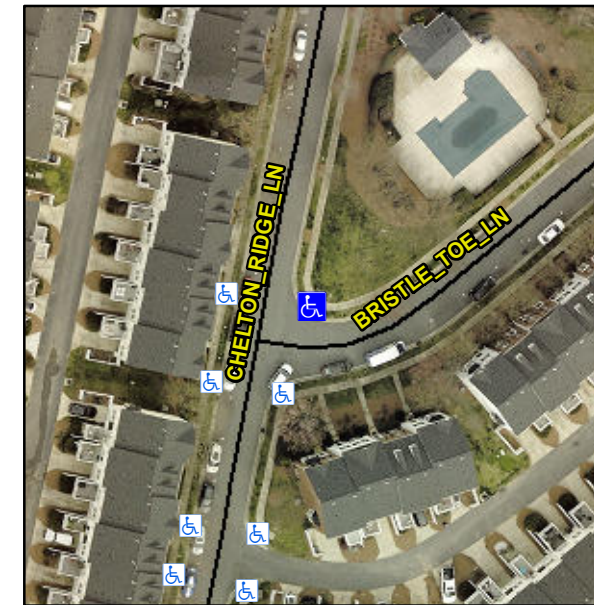
**LT RP < 5%**

**R304.5.1, R304.2.2, R304.5.3**

| Compliance | Description | Data | Compliance | Description | Data |
|---|---|---|---|---|---|
| No | Ramp XSlope LT (%) | 5.7 | Yes | Ramp XSlope RT (%) | 1.6 |
| N/A | Ramp Length (in) | 84.0 | No | Ramp Slope (%) | 9.0 |
| No | Ramp Width (in) | 39.0 | No | Ramp XSlope (%) | 6.4 |

**Remove & Replace Curb Ramp With Two New Directional Ramps or Equivalent.**
