Access Compliance Report

Public Rights-of-Way

(Curb Ramps)

Intersection ID: 28615	Main Street: CARDINAL_GLEN_CT	Cross Street: KESTRAL_RIDGE_DR	Location: SW
ADA ID: 5E692E86A327	Ramp Type: PerpDiag	Initial Pass/Fail: Pass	Overall Compliance: No
			Severity Score: 17.75

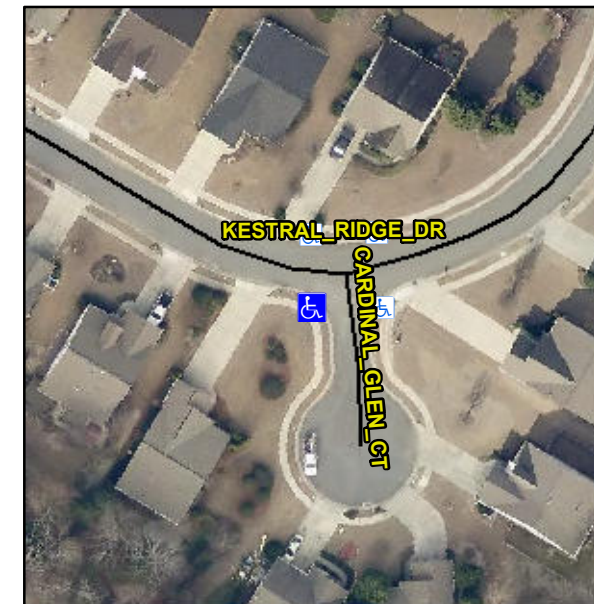
Not Found, R304.2.2, R304.5.3, R304.2.1, R304.2.2-Perp, R304.3.2-Para, R305, R304.5.4

Compliance	Description	Data	Compliance	Description	Data
N/A	Ramp Length (in)	47.0	No	Ramp Slope (%)	8.9
Yes	Ramp Width (in)	85.0	No	Ramp XSlope (%)	5.0
N/A	Flare Type LT	Sloped	N/A	Flare Type RT	N/A
N/A	Flare Slope LT (%)	4.5	N/A	Flare Slope RT (%)	2.4
N/A	Flare Traversable LT?	No	N/A	Flare Traversable RT?	No
No	Landing Length (in)	47.0	No	DWS Provided?	No
Yes	Landing Width (in)	99.0	N/A	DWS Contrast?	No
No	Landing Slope (%)	5.0	N/A	DWS Length (in)	N/A
Yes	Landing X Slope (%)	1.6	N/A	DWS Full Width?	No
N/A	Landing Curb? (Y/N)	No	N/A	DWS Offset (in)	N/A
N/A	Shared Landing?	No			
Yes	Gutter Ponding?	No	No	Gutter Slope (%)	10.2
Yes	Gutter Lip Ht (in)	0.0	Yes	Gutter X Slope (%)	1.9
N/A	Painted X Walk1?	No	N/A	Painted X Walk2?	No
	X Walk 1 Direction	To E		X Walk 2 Direction	To N
N/A	X Walk 1 Width (in)	N/A	N/A	X Walk 2 Width (in)	N/A
	X Walk 1 Slope (%)	1.3		X Walk 2 Slope (%)	2.1
	X Walk 1 X Slope (%)	0.5		X Walk 2 X Slope (%)	0.7

N/A	Ramp inside XWalk1?	N/A	N/A	Ramp inside XWalk2?	N/A
	Road Slope (%)	0.8	N/A	Clear Space?	Yes
	Road X Slope (%)	0.5	N/A	Clear Space to XWalk (in)	N/A
Yes	Any Obstructions?	No	Yes	Storm Grate/Utility Hazard?	No
	Obstruction Type			Storm Grate/Utility Type	
		N/A			N/A
			Yes	Surface Condition? (G/P)	Good

Remove & Replace Curb Ramp With Two New Directional Ramps or Equivalent. Remove & Replace Gutter.
