# Access Compliance Report

## Public Rights-of-Way

| Intersection ID: 10597 | Main Street: BELLE_PLAINE_DR | Cross Street: BRIARGROVE_DR | Location: NW |
| ADA ID: 5E6C1A774024 | Ramp Type: Perp | Initial Pass/Fail: Fail | Overall Compliance: No |

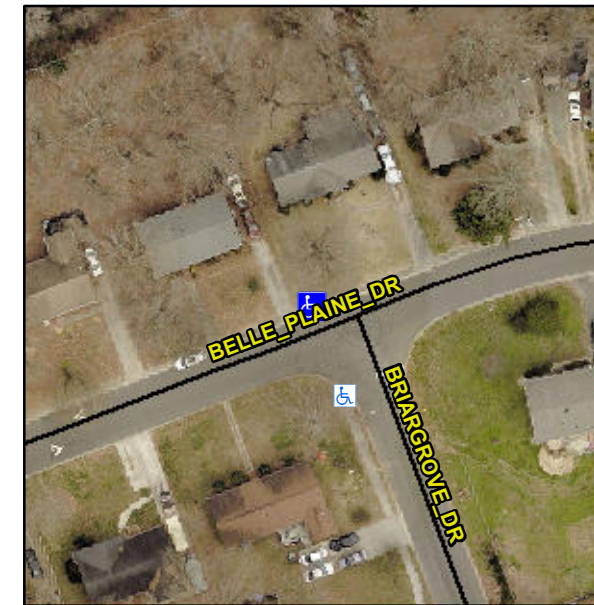
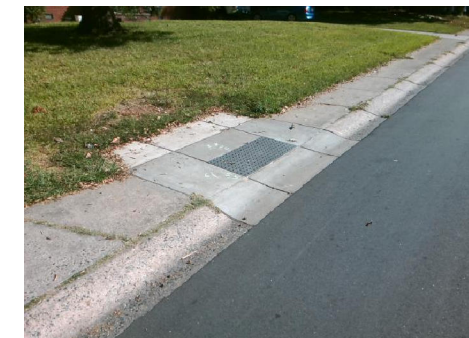
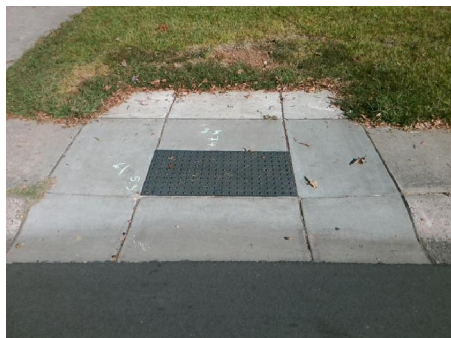
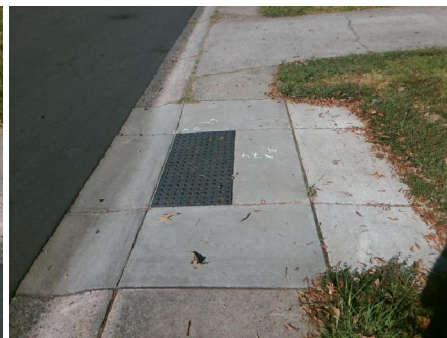
| | | Severity Score: 10 | |

**Not Found, R304.5.1**

| Compliance | Description | Data | Compliance | Description | Data |
|---|---|---|---|---|---|
| No | Ramp Width (in) | 47.0 | Yes | Ramp XSlope (%) | 3.8 |

**Remove & Replace Entire Ramp.**

Total Cost: \$ 1850.00
