Access Compliance Report

Public Rights-of-Way

(Curb Ramps)

Intersection ID: 23312	Main Street: BALTUSROL_LN	Cross Street: GLENEAGLES_RD	Location: SW
ADA ID: 5E95833E09CC	Ramp Type: PerpDiag	Initial Pass/Fail: Fail	Overall Compliance: No
Severity Score: 8.75			
Codes/Mitigation Info/Possible Solution		Field Measurements/Component Compliance

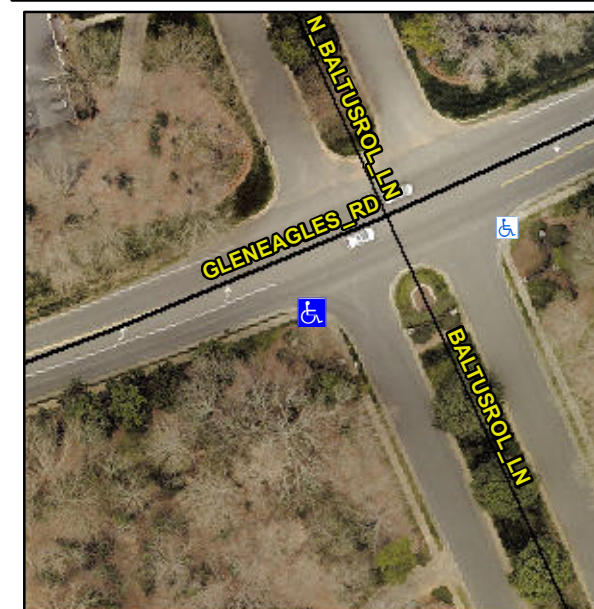
Not Found, R304.5.1

Compliance	Description	Data	Compliance	Description	Data
N/A	Ramp Length (in)	48.0	Yes	Ramp Slope (%)	6.8
No	Ramp Width (in)	46.5	Yes	Ramp XSlope (%)	0.5
N/A	Flare Type LT	N/A	N/A	Flare Type RT	N/A
N/A	Flare Slope LT (%)	N/A	N/A	Flare Slope RT (%)	N/A
N/A	Flare Traversable LT?	N/A	N/A	Flare Traversable RT?	N/A
N/A	Landing Length (in)	N/A	N/A	DWS Provided?	N/A
N/A	Landing Width (in)	N/A	N/A	DWS Contrast?	N/A
N/A	Landing Slope (%)	N/A	N/A	DWS Length (in)	N/A
N/A	Landing X Slope (%)	N/A	N/A	DWS Full Width?	N/A
N/A	Landing Curb? (Y/N)	N/A	N/A	DWS Offset (in)	N/A
N/A	Shared Landing?	N/A			
N/A	Gutter Ponding?	N/A	N/A	Gutter Slope (%)	N/A
N/A	Gutter Lip Ht (in)	N/A	N/A	Gutter X Slope (%)	N/A
N/A	Painted X Walk1?	No	N/A	Painted X Walk2?	No
	X Walk 1 Direction	To E		X Walk 2 Direction	To N
N/A	X Walk 1 Width (in)	N/A	N/A	X Walk 2 Width (in)	N/A
	X Walk 1 Slope (%)	1.6		X Walk 2 Slope (%)	5.7
	X Walk 1 X Slope (%)	3.7		X Walk 2 X Slope (%)	0.8

N/A	Ramp inside XWalk1?	N/A	N/A	Ramp inside XWalk2?	N/A
	Road Slope (%)	0.5	N/A	Clear Space?	N/A
	Road X Slope (%)	6.9	N/A	Clear Space to XWalk (in)	N/A
N/A	Any Obstructions?	N/A	N/A	Storm Grate/Utility Hazard?	N/A
	Obstruction Type			Storm Grate/Utility Type	
		N/A			N/A
		Yes		Surface Condition? (G/P)	Good

Possible Solutions:

Remove & Replace Curb Ramp With Two New Directional Ramps or Equivalent.
