Access Compliance Report

Public Rights-of-Way

(Curb Ramps)

Intersection ID: 10034489	Main Street: PINEBURR_RD	Cross Street: N/A	Location: NW
ADA ID: 5E9A0B9812A4	Ramp Type: BlendTrans2	Initial Pass/Fail: Fail	Overall Compliance: No
		Severity Score: 12.5

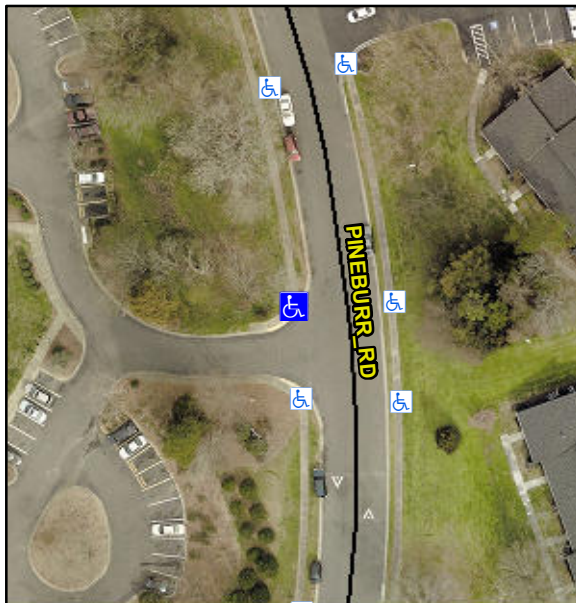
Not Found, R304.5.3

Compliance	Description	Data	Compliance	Description	Data
N/A	Ramp Length (in)	57.0	Yes	BlendTrans Slope (%)	1.6
Yes	Ramp Width (in)	48.0	No	BlendTrans XSlope (%)	5.2
N/A	Flare Type LT	N/A	N/A	Flare Type RT	N/A
N/A	Flare Slope LT (%)	N/A	N/A	Flare Slope RT (%)	N/A
N/A	Flare Traversable LT?	N/A	N/A	Flare Traversable RT?	N/A
N/A	Landing Length (in)	N/A	N/A	DWS Provided?	N/A
N/A	Landing Width (in)	N/A	N/A	DWS Contrast?	N/A
N/A	Landing Slope (%)	N/A	N/A	DWS Length (in)	N/A
N/A	Landing X Slope (%)	N/A	N/A	DWS Full Width?	N/A
N/A	Landing Curb? (Y/N)	N/A	N/A	DWS Offset (in)	N/A
N/A	Shared Landing?	N/A			
N/A	Gutter Ponding?	N/A	N/A	Gutter Slope (%)	N/A
N/A	Gutter Lip Ht (in)	N/A	N/A	Gutter X Slope (%)	N/A
N/A	Painted X Walk1?	No	N/A	Painted X Walk2?	No
	X Walk 1 Direction	To S		X Walk 2 Direction	To E
	X Walk 1 Width (in)	N/A		X Walk 2 Width (in)	N/A
	X Walk 1 Slope (%)	4.7		X Walk 2 Slope (%)	1.2
	X Walk 1 X Slope (%)	6.5		X Walk 2 X Slope (%)	0.0

N/A	Ramp inside XWalk1?	N/A	N/A	Ramp inside XWalk2?	N/A
	Road Slope (%)	3.7		Clear Space?	N/A
	Road X Slope (%)	1.0	N/A	Clear Space to XWalk (in)	N/A
N/A	Any Obstructions?	N/A	N/A	Storm Grate/Utility Hazard?	N/A
	Obstruction Type			Storm Grate/Utility Type	
		N/A			N/A
			Yes	Surface Condition? (G/P)	Good
			No	Curb Slope (%)	14.0

Remove & Replace Curb Ramp With Two New Directional Ramps or Equivalent.
