# Access Compliance Report

## Public Rights-of-Way

### (Curb Ramps)

Intersection ID: 17685	Main Street: MORGENSE_PL	Cross Street: REDSTONES_RD	Location: SW
ADA ID: 5EA4644050F5	Ramp Type: PerpDiag	Initial Pass/Fail: Fail	Overall Compliance: No
		Severity Score: 50

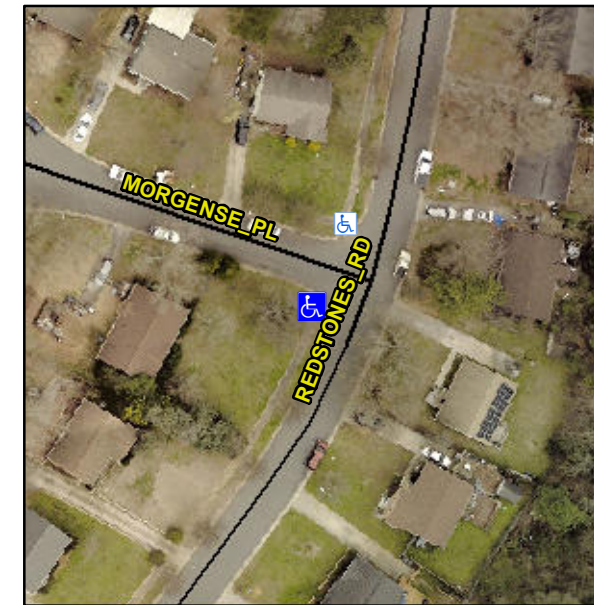
**Not Found, R304.2.2, R304.5.3**

Compliance	Description	Data	Compliance	Description	Data
N/A	Ramp Length (in)	69.0	No	Ramp Slope (%)	13.6
Yes	Ramp Width (in)	48.0	No	Ramp XSlope (%)	8.1
N/A	Flare Type LT	N/A	N/A	Flare Type RT	N/A
N/A	Flare Slope LT (%)	N/A	N/A	Flare Slope RT (%)	N/A
N/A	Flare Traversable LT?	N/A	N/A	Flare Traversable RT?	N/A
N/A	Landing Length (in)	N/A	N/A	DWS Provided?	N/A
N/A	Landing Width (in)	N/A	N/A	DWS Contrast?	N/A
N/A	Landing Slope (%)	N/A	N/A	DWS Length (in)	N/A
N/A	Landing X Slope (%)	N/A	N/A	DWS Full Width?	N/A
N/A	Landing Curb? (Y/N)	N/A	N/A	DWS Offset (in)	N/A
N/A	Shared Landing?	N/A			
N/A	Gutter Ponding?	N/A	N/A	Gutter Slope (%)	N/A
N/A	Gutter Lip Ht (in)	N/A	N/A	Gutter X Slope (%)	N/A
N/A	Painted X Walk1?	No	N/A	Painted X Walk2?	No
	X Walk 1 Direction	To SE		X Walk 2 Direction	To NE
N/A	X Walk 1 Width (in)	N/A	N/A	X Walk 2 Width (in)	N/A
	X Walk 1 Slope (%)	1.7		X Walk 2 Slope (%)	4.8
	X Walk 1 X Slope (%)	3.5		X Walk 2 X Slope (%)	5.8

N/A	Ramp inside XWalk1?	N/A	N/A	Ramp inside XWalk2?	N/A
	Road Slope (%)	4.9	N/A	Clear Space?	N/A
	Road X Slope (%)	0.8	N/A	Clear Space to XWalk (in)	N/A
N/A	Any Obstructions?	N/A	N/A	Storm Grate/Utility Hazard?	N/A
	Obstruction Type			Storm Grate/Utility Type	
		N/A			N/A
		Yes		Surface Condition? (G/P)	Good

**Remove & Replace Curb Ramp With Two New Directional Ramps or Equivalent.**
