Access Compliance Report

Public Rights-of-Way

(Curb Ramps)

Intersection ID: 42724	Main Street: SPEEDWELL_CT	Cross Street: WAKEROBIN_LN	Location: W
ADA ID: 5EAD939A2C85	Ramp Type: PerpDiag	Initial Pass/Fail: Fail	Overall Compliance: No
Severity Score: 18.75			
Codes/Mitigation Info/Possible Solution		Field Measurements/Component Compliance

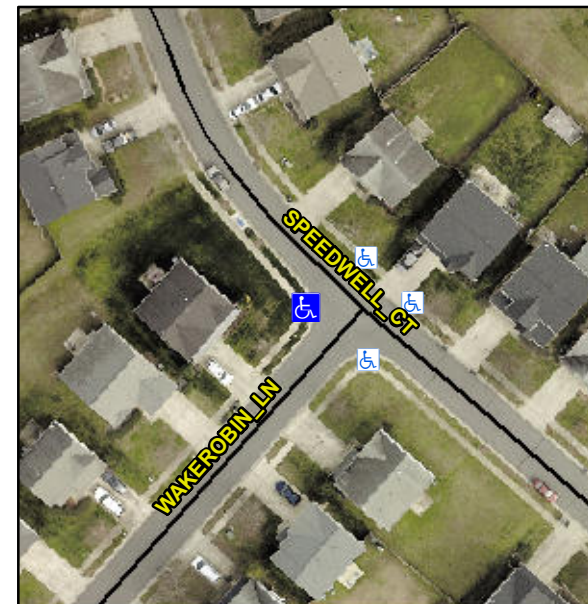
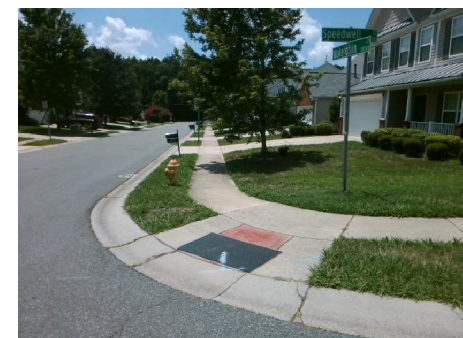
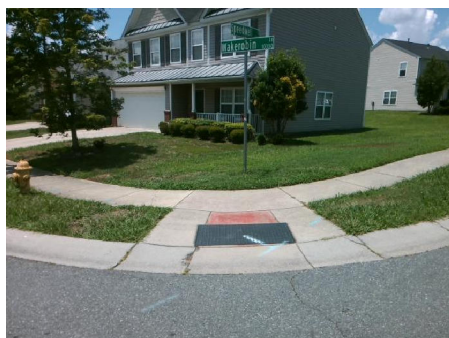
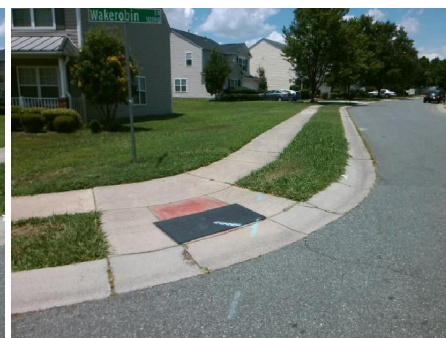
Not Found, R304.5.1, R304.5.3

Compliance	Description	Data	Compliance	Description	Data
N/A	Ramp Length (in)	48.0	Yes	Ramp Slope (%)	5.5
No	Ramp Width (in)	35.0	No	Ramp XSlope (%)	3.7
N/A	Flare Type LT	N/A	N/A	Flare Type RT	N/A
N/A	Flare Slope LT (%)	N/A	N/A	Flare Slope RT (%)	N/A
N/A	Flare Traversable LT?	N/A	N/A	Flare Traversable RT?	N/A
N/A	Landing Length (in)	N/A	N/A	DWS Provided?	N/A
N/A	Landing Width (in)	N/A	N/A	DWS Contrast?	N/A
N/A	Landing Slope (%)	N/A	N/A	DWS Length (in)	N/A
N/A	Landing X Slope (%)	N/A	N/A	DWS Full Width?	N/A
N/A	Landing Curb? (Y/N)	N/A	N/A	DWS Offset (in)	N/A
N/A	Shared Landing?	N/A			
N/A	Gutter Ponding?	N/A	N/A	Gutter Slope (%)	N/A
N/A	Gutter Lip Ht (in)	N/A	N/A	Gutter X Slope (%)	N/A
N/A	Painted X Walk1?	No	N/A	Painted X Walk2?	No
	X Walk 1 Direction	To SE		X Walk 2 Direction	To NE
N/A	X Walk 1 Width (in)	N/A	N/A	X Walk 2 Width (in)	N/A
	X Walk 1 Slope (%)	1.9		X Walk 2 Slope (%)	4.1
	X Walk 1 X Slope (%)	4.4		X Walk 2 X Slope (%)	4.9

N/A	Ramp inside XWalk1?	N/A	N/A	Ramp inside XWalk2?	N/A
	Road Slope (%)	5.3	N/A	Clear Space?	N/A
	Road X Slope (%)	5.3	N/A	Clear Space to XWalk (in)	N/A
N/A	Any Obstructions?	N/A	N/A	Storm Grate/Utility Hazard?	N/A
	Obstruction Type			Storm Grate/Utility Type	
		N/A			N/A
			Yes	Surface Condition? (G/P)	Good

Remove & Replace Curb Ramp With Two New Directional Ramps or Equivalent.
