## Access Compliance Report Public Rights-of-Way (Curb Ramps)

Intersection ID: 8925 Main Street: E\_W\_T\_HARRIS\_BV Cross Street: THE\_PLAZA Location: SE

ADA ID: 5EB0404ED60C Ramp Type: Para Initial Pass/Fail: Fail Overall Compliance: No Severity Score: 12.5

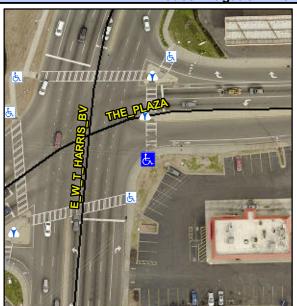
Field Measurements/Component Compliance								
Compli	ance Description	Data	Compl	iance Description	Data			
N/A	Ramp Length LT (in)	60.0	N/A	Ramp Length RT (in)	57.0			
Yes	Ramp Width LT (in)	83.5	Yes	Ramp Width RT (in)	83.5			
Yes	Ramp Slope LT (%)	5.3	No	Ramp Slope RT (%)	11.3			
Yes	Ramp XSlope LT (%)	1.9	Yes	Ramp XSlope RT (%)	1.4			
N/A	Landing Length (in)	N/A	N/A	DWS Provided?	N/A			
N/A	Landing Width (in)	N/A	N/A	DWS Contrast?	N/A			
N/A	Landing Slope (%)	N/A	N/A	DWS Length (in)	N/A			
N/A	Landing X Slope (%)	N/A	N/A	DWS Full Width?	N/A			
N/A	Landing Curb? (Y/N)	N/A	N/A	DWS Offset (in)	N/A			
N/A	Shared Landing?	N/A						
N/A	Gutter Ponding?	N/A	N/A	Gutter Slope (%)	N/A			
N/A	Gutter Lip Ht (in)	0.5	N/A	Gutter X Slope (%)	N/A			
N/A	Painted X Walk1?	Yes	N/A	Painted X Walk2?	N/A			
	X Walk 1 Direction	To N		X Walk 2 Direction	N/A			
N/A	X Walk 1 Width (in)	111.5	N/A	X Walk 2 Width (in)	N/A			
	X Walk 1 Slope (%)	2.4		X Walk 2 Slope (%)	N/A

COSTINE COLUTION	
Possible Solutions:	Co
Remove & Replace Entire Ramp.	N/A
·	Ye
	Ye
	Ye
	N/A
	N/A
Surveyor Notes:	N/A
N/A	N/A
	N/A
	N/A
	N/A
PROW/ADA:	N/A
R304.3.2	N/A
	N/A
	N//
