Access Compliance Report

Public Rights-of-Way

(Curb Ramps)

| Intersection ID: 25654 | Main Street: REA_RD | Cross Street: STALLWORTH_DR | Location: NW |

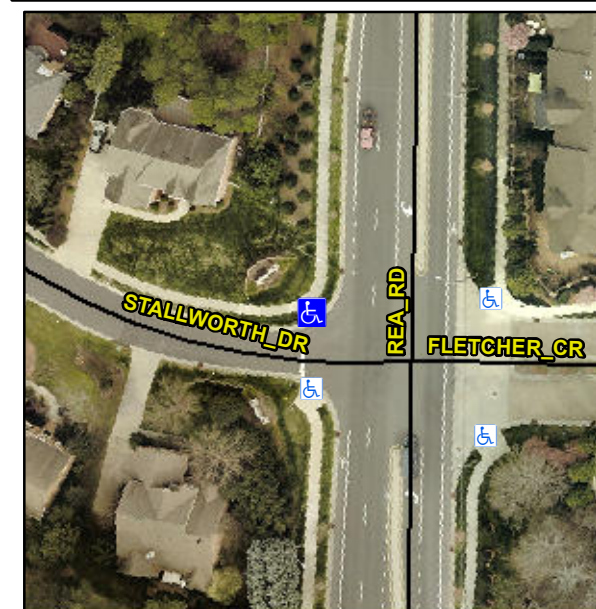
| ADA ID: 5EB8FB0487BB | Ramp Type: PerpDiag | Initial Pass/Fail: Fail | Overall Compliance: No |
| Severity Score: 22.5 | | | |

Not Found, R304.5.1, R304.2.2, R304.5.3

| Compliance | Description | Data | Compliance | Description | Data |
|---|---|---|---|---|---|
| N/A | Ramp Length (in) | 73.0 | No | Ramp Slope (%) | 8.6 |
| No | Ramp Width (in) | 47.5 | No | Ramp XSlope (%) | 3.8 |

Remove & Replace Curb Ramp With Two New Directional Ramps or Equivalent.

Total Cost: \$ 3200.00
