# Access Compliance Report

## Public Rights-of-Way

| Intersection ID: 50601 | Main Street: LUSTERLEAF_HOLLY_RD | Cross Street: HEARTLEAF_RD | Location: NE |
| ADA ID: 5EBA59656505 | Ramp Type: Perp | Initial Pass/Fail: Pass | Overall Compliance: No |

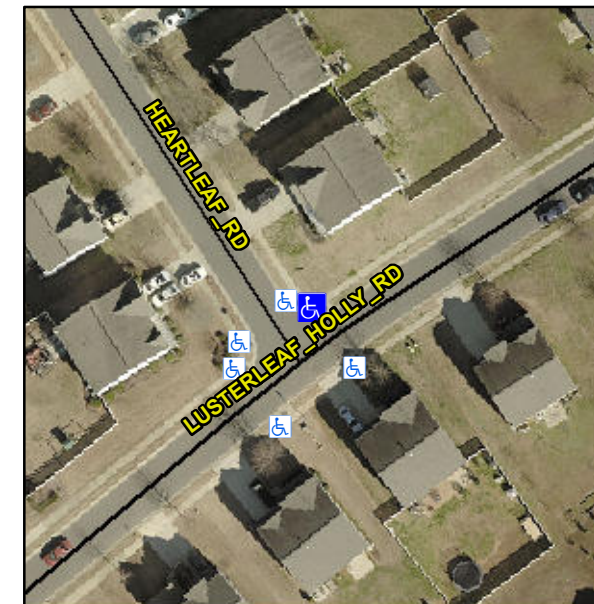
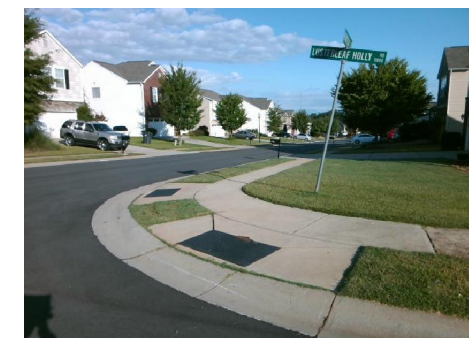
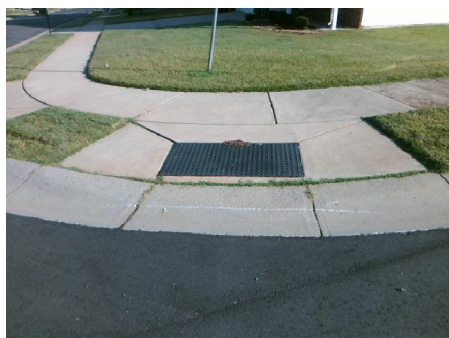
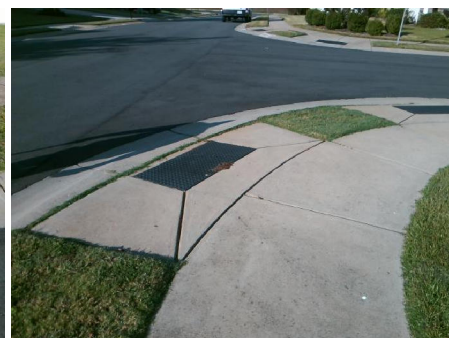
**Not Found, R304.5.3, R305.2,  
R304.5.4**

| Compliance | Description | Data | Compliance | Description | Data |
|---|---|---|---|---|---|
| Yes | Ramp Width (in) | 48.0 | No | Ramp XSlope (%) | 2.1 |
| N/A | Landing Curb? (Y/N) | No | No | DWS Offset (in) | 6.0 |
| Yes | Gutter Ponding? | No | No | Gutter Slope (%) | 11.9 |

**Remove & Replace Entire Ramp.  
Remove & Replace Gutter.**
