# Access Compliance Report

## Public Rights-of-Way

### (Curb Ramps)

Intersection ID: 11764	Main Street: BEACON_ST	Cross Street: MECKLENBURG_AV	Location: NW
ADA ID: 5EBADECCE46C	Ramp Type: Perp	Initial Pass/Fail: Fail	Overall Compliance: No
Severity Score: 35			
Codes/Mitigation Info/Possible Solution		Field Measurements/Component Compliance

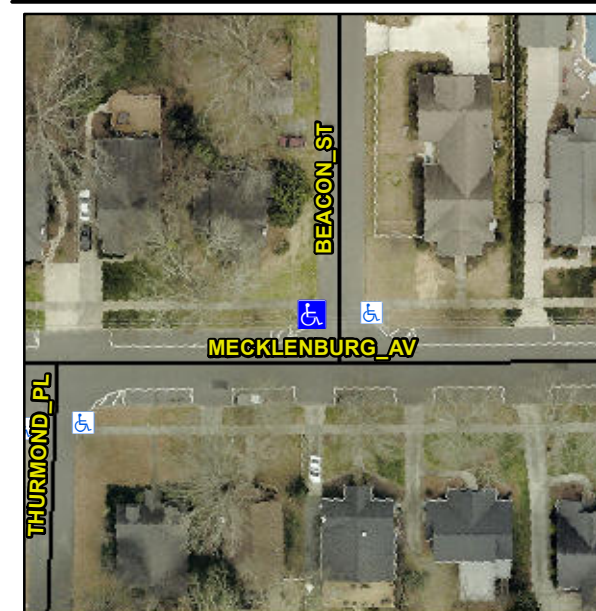
**Not Found, R304.5.1**

Compliance	Description	Data	Compliance	Description	Data
N/A	Ramp Length (in)	61.0	Yes	Ramp Slope (%)	7.8
No	Ramp Width (in)	30.0	Yes	Ramp XSlope (%)	2.0
N/A	Flare Type LT	N/A	N/A	Flare Type RT	N/A
N/A	Flare Slope LT (%)	N/A	N/A	Flare Slope RT (%)	N/A
N/A	Flare Traversable LT?	N/A	N/A	Flare Traversable RT?	N/A
N/A	Landing Length (in)	N/A	N/A	DWS Provided?	N/A
N/A	Landing Width (in)	N/A	N/A	DWS Contrast?	N/A
N/A	Landing Slope (%)	N/A	N/A	DWS Length (in)	N/A
N/A	Landing X Slope (%)	N/A	N/A	DWS Full Width?	N/A
N/A	Landing Curb? (Y/N)	N/A	N/A	DWS Offset (in)	N/A
N/A	Shared Landing?	N/A			
N/A	Gutter Ponding?	N/A	N/A	Gutter Slope (%)	N/A
N/A	Gutter Lip Ht (in)	0.5	N/A	Gutter X Slope (%)	N/A
N/A	Painted X Walk1?	No	N/A	Painted X Walk2?	N/A
	X Walk 1 Direction	To E		X Walk 2 Direction	N/A
N/A	X Walk 1 Width (in)	N/A	N/A	X Walk 2 Width (in)	N/A
	X Walk 1 Slope (%)	2.7		X Walk 2 Slope (%)	N/A
	X Walk 1 X Slope (%)	2.9		X Walk 2 X Slope (%)	N/A

N/A	Ramp inside XWalk1?	N/A	N/A	Ramp inside XWalk2?	N/A
	Road Slope (%)	N/A	N/A	Clear Space?	N/A
	Road X Slope (%)	N/A	N/A	Clear Space to XWalk (in)	N/A
N/A	Any Obstructions?	N/A	N/A	Storm Grate/Utility Hazard?	N/A
	Obstruction Type			Storm Grate/Utility Type	
		N/A			N/A
			Yes	Surface Condition? (G/P)	Good

**Remove & Replace Entire Ramp.**
