# Access Compliance Report

## Public Rights-of-Way

### (Curb Ramps)

| Intersection ID: 49223 | Main Street: ERIN_TAYLOR_LN | Cross Street: ANNA_GARRISON_RD | Location: S |

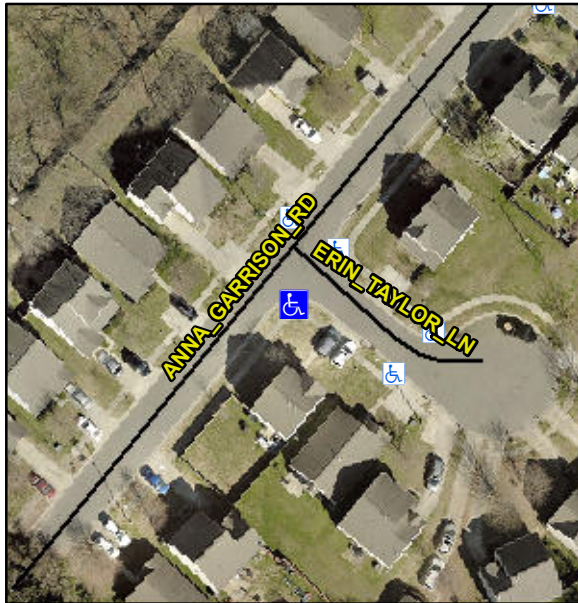
| ADA ID: 5EBDDD3D1AD1 | Ramp Type: PerpDiag | Initial Pass/Fail: Fail | Overall Compliance: No |
| Severity Score: 35 | | | |

**Not Found, R304.5.1**

| Compliance | Description | Data | Compliance | Description | Data |
|---|---|---|---|---|---|
| No | Ramp Width (in) | 30.0 | Yes | Ramp XSlope (%) | 1.2 |

**Remove & Replace Curb Ramp With Two New Directional Ramps or Equivalent.**

Total Cost: \$ 3200.00
