Access Compliance Report Public Rights-of-Way (Curb Ramps)

Intersection ID: 15991	section ID: 15991 Main Street: BUNCHE_DR				WHEATLEY_AV	Location:	NE		
ADA ID: 5ED039D484E2				Initial Pass/Fail: Fail Overall Compliance: No				Severity Score:	12.5
Codes/Mitigation Info/Possible Solution				Field Measurements/Component Compliance					
200 - 200 - 200 - 200 - 200 - 200 - 200 - 200 - 200 - 200 - 200 - 200 - 200 - 200 - 200 - 200 - 200 - 200 - 200		Possible Solutions:					Comp	Compliance Description Data	
		Remove & Replace Curb Ramp V	Vith	N/A	Ramp Length (in)	55.0	Yes	Ramp Slope (%)	8.1
		Two New Directional Ramps or Equivalent.	-	Yes	Ramp Width (in)	48.0	No	Ramp XSlope (%)	6.0
				N/A	Flare Type LT	N/A	N/A	Flare Type RT	N/A
				N/A	Flare Slope LT (%)	N/A	N/A	Flare Slope RT (%)	N/A
				N/A	Flare Traversable LT?	N/A	N/A	Flare Traversable RT?	N/A
	A And a			N/A	Landing Length (in)	N/A	N/A	DWS Provided?	N/A
		Surveyor Notes:		N/A	Landing Width (in)	N/A	N/A	DWS Contrast?	N/A

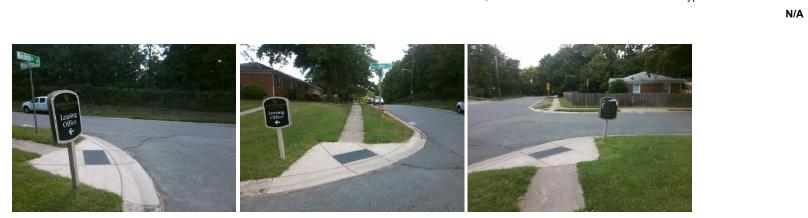
the Charles of the second		N/A		N/A	Landing Slope (%)	N/A	N/A	DWS Length (in)	N/A
WHEATLEY_AV				N/A	Landing X Slope (%)	N/A	N/A	DWS Full Width?	N/A
the state of the s			N/A	Landing Curb? (Y/N)	N/A	N/A	DWS Offset (in)	N/A	
a day 1 & was transmith			N/A	Shared Landing?	N/A				
		PROW/ADA:		N/A	Gutter Ponding?	N/A	N/A	Gutter Slope (%)	N/A
		Not Found, R304.5.3		N/A	Gutter Lip Ht (in)	N/A	N/A	Gutter X Slope (%)	N/A
				N/A	Painted X Walk1?	No	N/A	Painted X Walk2?	No
					X Walk 1 Direction	To W		X Walk 2 Direction	To S
			N/A	X Walk 1 Width (in)	N/A	N/A	X Walk 2 Width (in)	N/A	
Street 1 Name	BUNCHE DR	-			X Walk 1 Slope (%)	0.2		X Walk 2 Slope (%)	6.8
Stop Condition-Street 2	StopSign				X Walk 1 X Slope (%)	5.4		X Walk 2 X Slope (%)	3.6
Street 2 Name	WHEATLEY AV			N/A	Ramp inside XWalk1?	N/A	N/A	Ramp inside XWalk2?	N/A
Stop Condition-Street 1	None				Road Slope (%)	4.1	N/A	Clear Space?	N/A
					Road X Slope (%)	3.6	N/A	Clear Space to XWalk (in)	N/A

N/A	Any Obstructions?	N/A	N/A	Storm Grate/Utility Hazard?	N/A
		Total Cost: \$ 3	200.00		Obstruction Type			Storm Grate/Utility Type	
						N/A			N/A
