## **Access Compliance Report Public Rights-of-Way** (Curb Ramps)

Intersection ID: 49659 Main Street: GREEN TRAIL LN Cross Street: WINDING\_PATH\_WY Location: SE ADA ID: 5ED4642FF382 Ramp Type: IslandPerp Initial Pass/Fail: Fail **Overall Compliance: No Severity Score:** 12.5

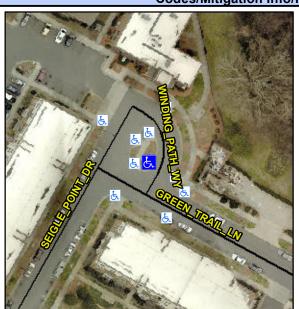
WINDING PATH WY Street 1 Name Stop Condition-Street 2 StopSign Street 2 Name N/A Stop Condition-Street 1 N/A Possible Solutions: Remove & Replace Entire Ramp. Surveyor Notes: N/A PROW/ADA: Not Found, R304.2.2
