Access Compliance Report

Public Rights-of-Way

(Curb Ramps)

Intersection ID: 21456	Main Street: REGENT RIDGE LN	Cross Street: WITHERS MILL DR	Location:	N
ADA ID: 5ED6F368477B	Ramp Type: Directional1	Initial Pass/Fail: Fail	Overall Compliance: No	Severity Score: 25

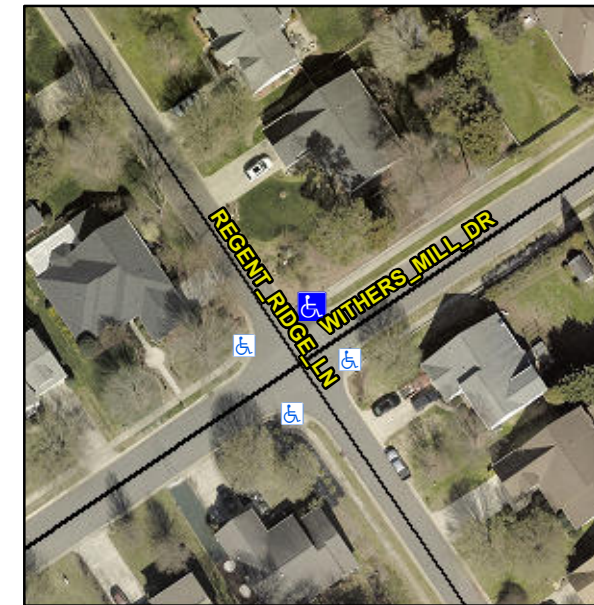
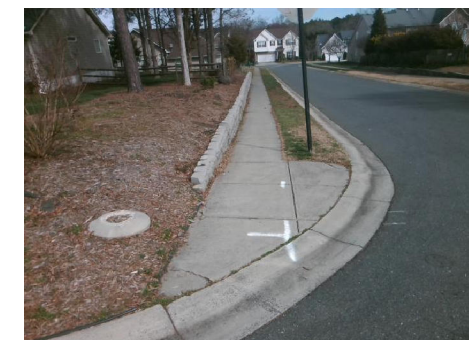
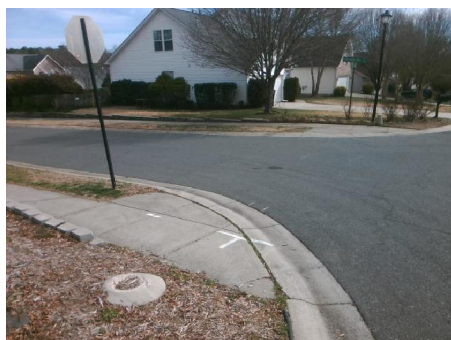
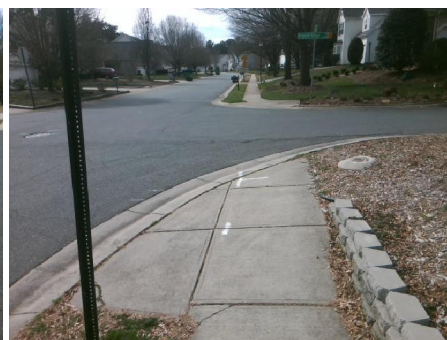
R304.5.3

Compliance	Description	Data	Compliance	Description	Data
N/A	Ramp Length (in)	48.0	N/A	Grade Break?	N/A
Yes	Ramp Width (in)	48.0	N/A	Grade Break Slope (%)	0.0
Yes	Ramp Slope (%)	0.2	N/A	Grade Break XSlope (%)	0.0
No	Ramp XSlope (%)	9.6			
N/A	Flare Type LT	N/A	N/A	Flare Type RT	N/A
N/A	Flare Slope LT (%)	N/A	N/A	Flare Slope RT (%)	0.0
N/A	Flare Traversable LT?	N/A	N/A	Flare Traversable RT?	N/A
N/A	Landing Length (in)	0.0	N/A	DWS Provided?	N/A
N/A	Landing Width (in)	0.0	N/A	DWS Contrast?	N/A
N/A	Landing Slope (%)	0.0	N/A	DWS Length (in)	N/A
N/A	Landing X Slope (%)	0.0	N/A	DWS Full Width?	N/A
N/A	Landing Curb? (Y/N)	N/A	N/A	DWS Offset LT (in)	N/A
N/A	Shared Landing?	N/A	N/A	DWS Offset RT (in)	N/A
N/A	Gutter Ponding?	0.0	N/A	Gutter Slope (%)	N/A
N/A	Gutter Lip Ht (in)	0.0	N/A	Gutter X Slope (%)	N/A
N/A	Painted X Walk1?	No		Road Slope (%)	5.1
	X Walk 1 Direction	To SW		Road X Slope (%)	3.4
	X Walk 1 Width (in)	N/A		Clear Space?	N/A

X Walk 1 Slope (%)	5.1	N/A	Clear Space to XWalk (in)	N/A
	X Walk 1 X Slope (%)	3.4	N/A	Storm Grate/Utility Hazard?	N/A
N/A	Ramp inside XWalk1?	N/A		Storm Grate/Utility Type	
N/A	Any Obstructions?	N/A			N/A
	Obstruction Type		Yes	Surface Condition? (G/P)	Good
			N/A	Curb Slope (%)	5.0

Remove & Replace Entire Ramp.
