Access Compliance Report Public Rights-of-Way (Curb Ramps)

Intersection ID: 10020713Main Street: BEATTIES_FORD_RDCross Street: N/ALocation:EADA ID: 5EDEFC695C34Ramp Type: PerpInitial Pass/Fail: FailOverall Compliance: NoSeverity Score:10

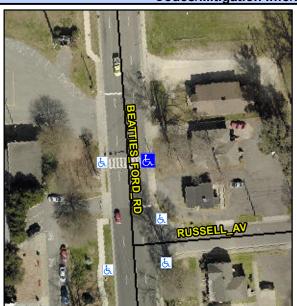
Comp	liance Description	Data	Comp	liance Description	Data
N/A	Ramp Length (in)	60.0	Yes	Ramp Slope (%)	5.0
No	Ramp Width (in)	44.0	No	Ramp XSlope (%)	3.1
N/A	Flare Type LT	N/A	N/A	Flare Type RT	N/A
N/A	Flare Slope LT (%)	N/A	N/A	Flare Slope RT (%)	N/A
N/A	Flare Traversable LT?	N/A	N/A	Flare Traversable RT?	N/A
N/A	Landing Length (in)	N/A	N/A	DWS Provided?	N/A
N/A	Landing Width (in)	N/A	N/A	DWS Contrast?	N/A
N/A	Landing Slope (%)	N/A	N/A	DWS Length (in)	N/A
N/A	Landing X Slope (%)	N/A	N/A	DWS Full Width?	N/A
N/A	Landing Curb? (Y/N)	N/A	N/A	DWS Offset (in)	N/A
N/A	Shared Landing?	N/A			
N/A	Gutter Ponding?	N/A	N/A	Gutter Slope (%)	N/A
N/A	Gutter Lip Ht (in)	N/A	N/A	Gutter X Slope (%)	N/A
N/A	Painted X Walk1?	Yes	N/A	Painted X Walk2?	N/A
	X Walk 1 Direction	To W		X Walk 2 Direction	N/A
N/A	X Walk 1 Width (in)	112.0	N/A	X Walk 2 Width (in)	N/A
	X Walk 1 Slope (%)	3.5		X Walk 2 Slope (%)	N/A
	X Walk 1 X Slope (%)	1.1		X Walk 2 X Slope (%)	N/A

N/A	Ramp inside XWalk1?	Yes	N/A	Ramp inside XWalk2?	N/A
	Road Slope (%)	N/A	N/A	Clear Space?	N/A
	Road X Slope (%)	N/A	N/A	Clear Space to XWalk (in)	N/A
N/A	Any Obstructions?	N/A	N/A	Storm Grate/Utility Hazard?	N/A
	Obstruction Type			Storm Grate/Utility Type	
		N/A			N/A
			Yes	Surface Condition? (G/P)	Good
No.	A CONTRACTOR OF THE PARTY OF TH

Possible Solutions:	<u>c</u>	
Remove & Replace Entire Ramp.		
	N	
	N	
	N	
	N	
	N	
Surveyor Notes:	N	
N/A	N	
	N	
	N	
	N	
PROW/ADA:	N	
Not Found, R304.5.1, R304.5.3	N	
, ,	N	
	N	
	N
