Access Compliance Report Public Rights-of-Way (Curb Ramps)

Intersection ID: 8328 Main Street: CENTRE_ST Cross Street: RAYON_ST Location: N

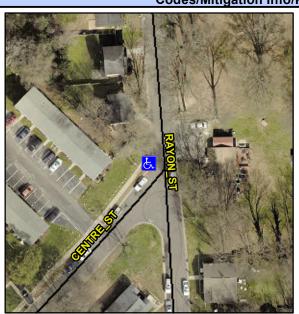
Initial Pass/Fail: Fail

Overall Compliance: No

PROW/ADA:
Not Found, R304.5.3

Fleid Measurements/Component Compliance							
	Compliance Description		Data	Compliance		Description	Data
	N/A	Ramp Length (in)	50.0	Yes	Blend	Trans Slope (%)	4.7
	Yes	Ramp Width (in)	48.0	No	Blend	Trans XSlope (%)	5.2
	N/A	Flare Type LT	N/A	N/A	Flare	Type RT	N/A
	N/A	Flare Slope LT (%)	N/A	N/A	Flare	Slope RT (%)	N/A
	N/A	Flare Traversable LT?	N/A	N/A	Flare	Traversable RT?	N/A
	N/A	Landing Length (in)	N/A	N/A	DWS	Provided?	N/A
	N/A	Landing Width (in)	N/A	N/A	DWS	Contrast?	N/A
	N/A	Landing Slope (%)	N/A	N/A	DWS	Length (in)	N/A
	N/A	Landing X Slope (%)	N/A	N/A	DWS	Full Width?	N/A
	N/A	Landing Curb? (Y/N)	N/A	N/A	DWS	Offset (in)	N/A
	N/A	Shared Landing?	N/A				
	N/A	Gutter Ponding?	N/A	N/A	Gutte	r Slope (%)	N/A
	N/A	Gutter Lip Ht (in)	N/A	N/A	Gutte	r X Slope (%)	N/A
	N/A	Painted X Walk1?	No	N/A	Painte	ed X Walk2?	No
		X Walk 1 Direction	To S		X Wal	lk 2 Direction	To E
		X Walk 1 Width (in)	N/A		X Wal	lk 2 Width (in)	N/A

X Walk 1 Slope (%)	2.4		X Wal	lk 2 Slope (%)	N/A
		X Walk 1 X Slope (%)	1.8		X Wal	lk 2 X Slope (%)	N/A
	N/A	Ramp inside XWalk1?	N/A	N/A	Ramp	inside XWalk2?	N/A
		Road Slope (%)	1.8		Clear	Space?	N/A
		Road X Slope (%)	2.4	N/A	Clear	Space to XWalk (in)	N/A
	N/A	Any Obstructions?	N/A	N/A	Storm	Grate/Utility Hazard?	N/A
				1	_

CENTRE ST StopSign RAYON ST None Possible Solutions:

Remove & Replace Curb Ramp With
Two New Directional Ramps or
Equivalent.

Total Cost: \$ 3200.00
