# Access Compliance Report

## Public Rights-of-Way

### (Curb Ramps)

Intersection ID: 25859	Main Street: CARY_RIDGE_DR	Cross Street: CORRIGAN_CT	Location: SE
ADA ID: 5EE9914E9B1E	Ramp Type: PerpDiag	Initial Pass/Fail: Fail	Overall Compliance: No
Severity Score: 22.5			
Codes/Mitigation Info/Possible Solution		Field Measurements/Component Compliance

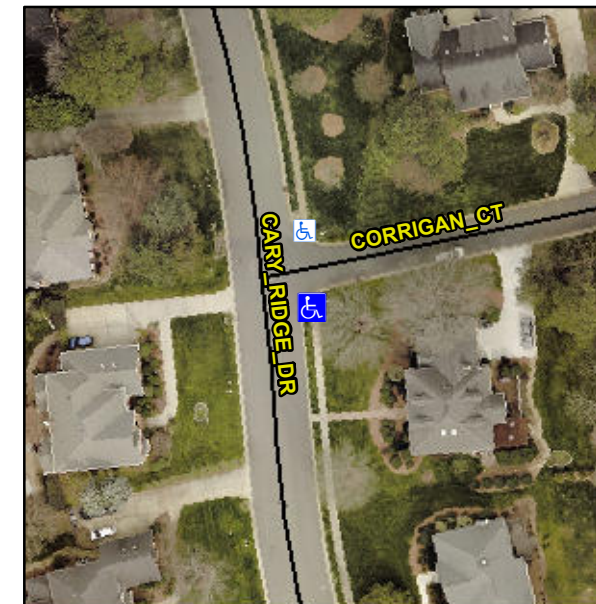
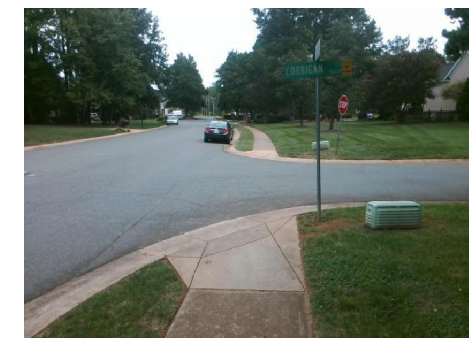
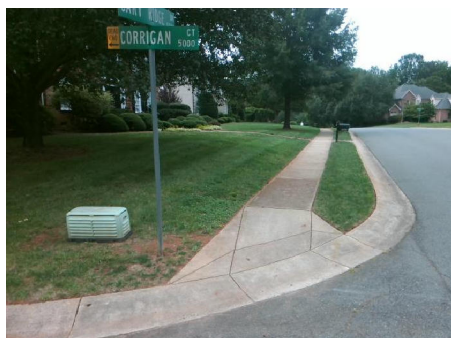
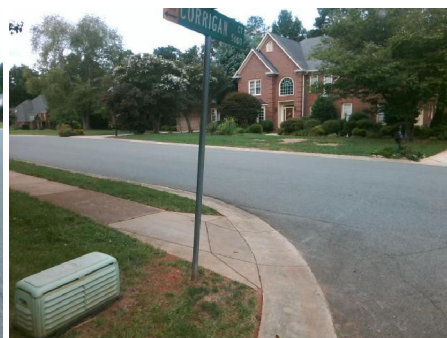
**Not Found, R304.5.1, R304.2.2, R304.5.3**

Compliance	Description	Data	Compliance	Description	Data
N/A	Ramp Length (in)	62.0	No	Ramp Slope (%)	9.7
No	Ramp Width (in)	39.0	No	Ramp XSlope (%)	2.1
N/A	Flare Type LT	N/A	N/A	Flare Type RT	N/A
N/A	Flare Slope LT (%)	N/A	N/A	Flare Slope RT (%)	N/A
N/A	Flare Traversable LT?	N/A	N/A	Flare Traversable RT?	N/A
N/A	Landing Length (in)	N/A	N/A	DWS Provided?	N/A
N/A	Landing Width (in)	N/A	N/A	DWS Contrast?	N/A
N/A	Landing Slope (%)	N/A	N/A	DWS Length (in)	N/A
N/A	Landing X Slope (%)	N/A	N/A	DWS Full Width?	N/A
N/A	Landing Curb? (Y/N)	N/A	N/A	DWS Offset (in)	N/A
N/A	Shared Landing?	N/A			
N/A	Gutter Ponding?	N/A	N/A	Gutter Slope (%)	N/A
N/A	Gutter Lip Ht (in)	N/A	N/A	Gutter X Slope (%)	N/A
N/A	Painted X Walk1?	No	N/A	Painted X Walk2?	No
	X Walk 1 Direction	To N		X Walk 2 Direction	To W
N/A	X Walk 1 Width (in)	N/A	N/A	X Walk 2 Width (in)	N/A
	X Walk 1 Slope (%)	0.2		X Walk 2 Slope (%)	6.7
	X Walk 1 X Slope (%)	3.2		X Walk 2 X Slope (%)	3.7

N/A	Ramp inside XWalk1?	N/A	N/A	Ramp inside XWalk2?	N/A
	Road Slope (%)	1.5	N/A	Clear Space?	N/A
	Road X Slope (%)	0.4	N/A	Clear Space to XWalk (in)	N/A
N/A	Any Obstructions?	N/A	N/A	Storm Grate/Utility Hazard?	N/A
	Obstruction Type			Storm Grate/Utility Type	
		N/A			N/A
			Yes	Surface Condition? (G/P)	Good

**Remove & Replace Curb Ramp With Two New Directional Ramps or Equivalent.**
