# Access Compliance Report

## Public Rights-of-Way

### (Curb Ramps)

Intersection ID: 3920	Main Street: OVERLOOK_MOUNTAIN_DR	Cross Street: OVERLOOK_COVE_RD	Location: SW
ADA ID: 5EECC439B936	Ramp Type: Perp	Initial Pass/Fail: Fail	Overall Compliance: No
Codes/Mitigation Info/Possible Solution		Field Measurements/Component Compliance	
Severity Score: 33.75

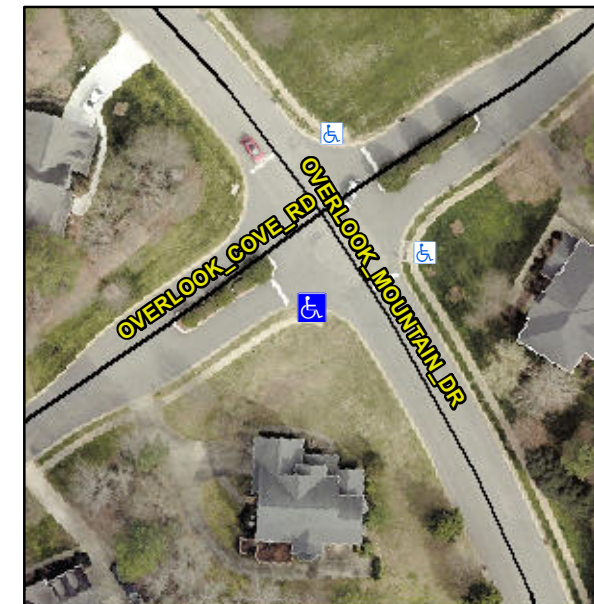
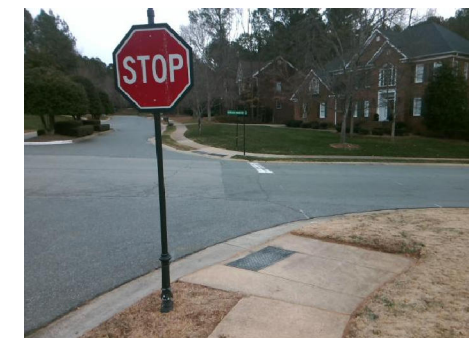
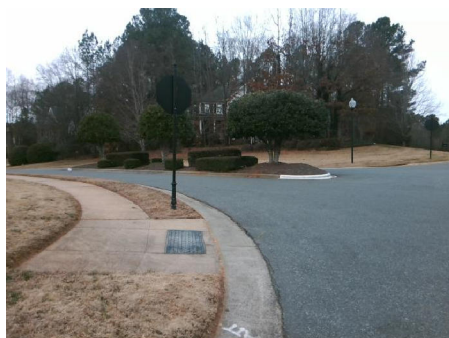
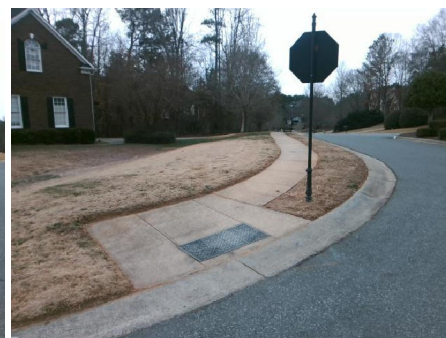
Compliance	Description	Data	Compliance	Description	Data
N/A	Ramp Length (in)	93.0	Yes	Ramp Slope (%)	5.6
No	Ramp Width (in)	44.0	No	Ramp XSlope (%)	10.7
N/A	Flare Type LT	N/A	N/A	Flare Type RT	N/A
N/A	Flare Slope LT (%)	N/A	N/A	Flare Slope RT (%)	N/A
N/A	Flare Traversable LT?	N/A	N/A	Flare Traversable RT?	N/A
N/A	Landing Length (in)	N/A	N/A	DWS Provided?	N/A
N/A	Landing Width (in)	N/A	N/A	DWS Contrast?	N/A
N/A	Landing Slope (%)	N/A	N/A	DWS Length (in)	N/A
N/A	Landing X Slope (%)	N/A	N/A	DWS Full Width?	N/A
N/A	Landing Curb? (Y/N)	N/A	N/A	DWS Offset (in)	N/A
N/A	Shared Landing?	N/A			
N/A	Gutter Ponding?	N/A	N/A	Gutter Slope (%)	N/A
N/A	Gutter Lip Ht (in)	N/A	N/A	Gutter X Slope (%)	N/A
N/A	Painted X Walk1?	No	N/A	Painted X Walk2?	N/A
	X Walk 1 Direction	To NE		X Walk 2 Direction	N/A
N/A	X Walk 1 Width (in)	N/A	N/A	X Walk 2 Width (in)	N/A
	X Walk 1 Slope (%)	2.5		X Walk 2 Slope (%)	N/A
	X Walk 1 X Slope (%)	7.3		X Walk 2 X Slope (%)	N/A

N/A	Ramp inside XWalk1?	N/A	N/A	Ramp inside XWalk2?	N/A
	Road Slope (%)	N/A	N/A	Clear Space?	N/A
	Road X Slope (%)	N/A	N/A	Clear Space to XWalk (in)	N/A
N/A	Any Obstructions?	N/A	N/A	Storm Grate/Utility Hazard?	N/A
	Obstruction Type			Storm Grate/Utility Type	
		N/A			N/A
			Yes	Surface Condition? (G/P)	Good

**Remove & Replace Entire Ramp.**

**R304.5.1, R304.5.3**
