Access Compliance Report Public Rights-of-Way (Curb Ramps)

Intersection ID: 18541	Main Str	Main Street: PROVIDENCE_RD			Street:	WESTBURY_RD	Location:	Ν			
ADA ID: 5EF4BBA4CB15	Ramp Type: Perp			Initial Pass/Fail: Fail Overall Compliance: No				o Severity Score:	21.25		
Codes/Mitigation Info/Possible Solution					Field Measurements/Component Compliance						
Possible Solutions:				Compliance Description Data Complian					Data		
NIL TO A	ANT Sale	Remove & Replace En	iro Ramn		N/A	Ramp Length (in)	57.0	No	Ramp Slope (%)	8.9

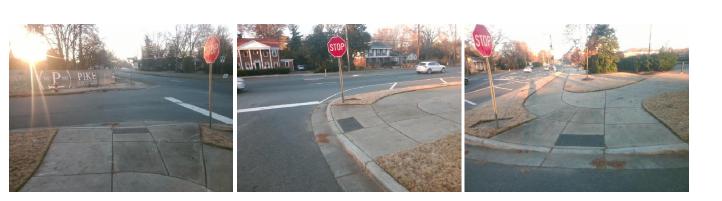
•	No	Ramp Width (in)	45.0	Yes	Ramp XSlope (%)	0.5	
					N/A	Flare Type LT	N/A	N/A	Flare Type RT	N/A	
and the second	2				N/A	Flare Slope LT (%)	N/A		Flare Slope RT (%)	N/A	
A PALES	R A				N/A	Flare Traversable LT?	N/A	N/A	Flare Traversable RT?	N/A	
					N/A	Landing Length (in)	N/A	N/A	DWS Provided?	N/A	
A Share B		Surveyor Notes:			N/A	Landing Width (in)	N/A	N/A	DWS Contrast?	N/A	
	and the second	N/A			N/A	Landing Slope (%)	N/A		DWS Length (in)	N/A
