# Access Compliance Report

## Public Rights-of-Way

### (Curb Ramps)

Intersection ID: 8537	Main Street: BEATTIES_FORD_RD	Cross Street: ST_LUKE_ST	Location: NE
ADA ID: 5F08C45172C9	Ramp Type: BlendTrans1	Initial Pass/Fail: Fail	Overall Compliance: No
			Severity Score: 21.25

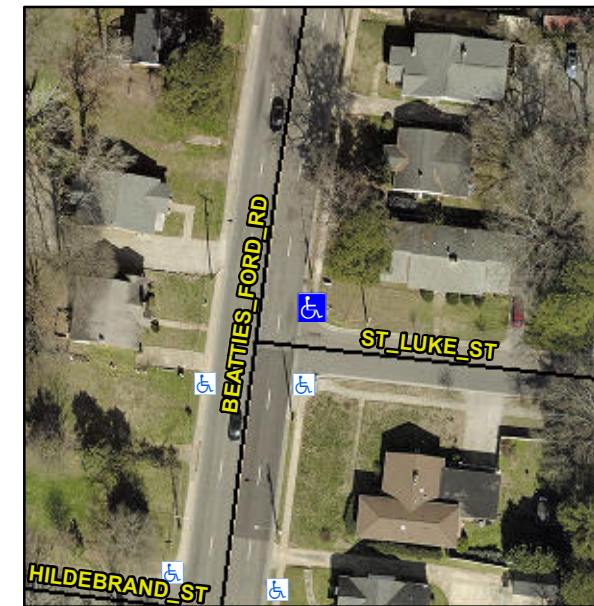
**NO RT SW**

**R304.5.1, R304.5.3**

Compliance	Description	Data	Compliance	Description	Data
N/A	Ramp Length (in)	72.0	Yes	BlendTrans Slope (%)	4.0
No	Ramp Width (in)	47.5	No	BlendTrans XSlope (%)	5.1
N/A	Flare Type LT	N/A	N/A	Flare Type RT	N/A
N/A	Flare Slope LT (%)	N/A	N/A	Flare Slope RT (%)	N/A
N/A	Flare Traversable LT?	N/A	N/A	Flare Traversable RT?	N/A
N/A	Landing Length (in)	N/A	N/A	DWS Provided?	N/A
N/A	Landing Width (in)	N/A	N/A	DWS Contrast?	N/A
N/A	Landing Slope (%)	N/A	N/A	DWS Length (in)	N/A
N/A	Landing X Slope (%)	N/A	N/A	DWS Full Width?	N/A
N/A	Landing Curb? (Y/N)	N/A	N/A	DWS Offset (in)	N/A
N/A	Shared Landing?	N/A			
N/A	Gutter Ponding?	N/A	N/A	Gutter Slope (%)	N/A
N/A	Gutter Lip Ht (in)	N/A	N/A	Gutter X Slope (%)	N/A
N/A	Painted X Walk1?	No	N/A	Painted X Walk2?	N/A
	X Walk 1 Direction	To S		X Walk 2 Direction	N/A
	X Walk 1 Width (in)	N/A		X Walk 2 Width (in)	N/A
	X Walk 1 Slope (%)	0.6		X Walk 2 Slope (%)	N/A
	X Walk 1 X Slope (%)	6.5		X Walk 2 X Slope (%)	N/A

N/A	Ramp inside XWalk1?	N/A	N/A	Ramp inside XWalk2?	N/A
	Road Slope (%)	6.5		Clear Space?	N/A
	Road X Slope (%)	0.6	N/A	Clear Space to XWalk (in)	N/A
N/A	Any Obstructions?	N/A	N/A	Storm Grate/Utility Hazard?	N/A
	Obstruction Type			Storm Grate/Utility Type	
		N/A			N/A
			Yes	Surface Condition? (G/P)	Good
			N/A	Curb Slope (%)	2.4

**Remove & Replace Curb Ramp With Two New Directional Ramps or Equivalent.**
