# Access Compliance Report

## Public Rights-of-Way

### (Curb Ramps)

| Intersection ID: 15153 | Main Street: GRIFFITH_ST | Cross Street: POINDEXTER_DR | Location: SW |

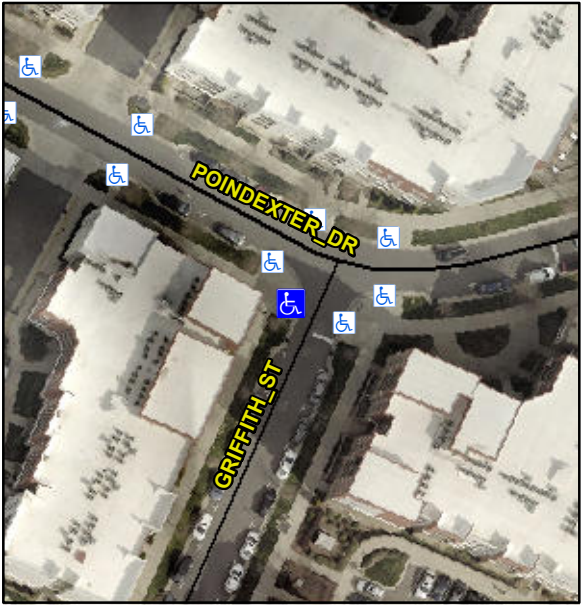
| ADA ID: 5F102ED14567 | Ramp Type: Perp | Initial Pass/Fail: Fail | Overall Compliance: No |
| | | Severity Score: 12.5 | |

| Codes/Mitigation Info/Possible Solution | | | Field Measurements/Component Compliance | | |
|---|---|---|---|---|---|
| | <b>Remove &amp; Replace Entire Ramp.</b> | | <b>No</b> | Ramp Length (in) | 74.0 |
| <p>Surveyor Notes:</p> <p><b>N/A</b></p> <p>PROW/ADA:</p> <p><b>Not Found, R304.2.2</b></p> | | | <b>N/A</b> | Flare Type RT | N/A |

| Codes/Mitigation Info/Possible Solution | | | Field Measurements/Component Compliance | | |
|---|---|---|---|---|---|
| Total Cost: | | \$ 1850.00 | | | |
