Access Compliance Report

Public Rights-of-Way

(Curb Ramps)

Intersection ID: 10027081	Main Street: GALLERIA_BV	Cross Street: N/A	Location: SW
ADA ID: 5F11F9362678	Ramp Type: PerpDiag	Initial Pass/Fail: Fail	Overall Compliance: No
Codes/Mitigation Info/Possible Solution		Field Measurements/Component Compliance	
Severity Score: 35

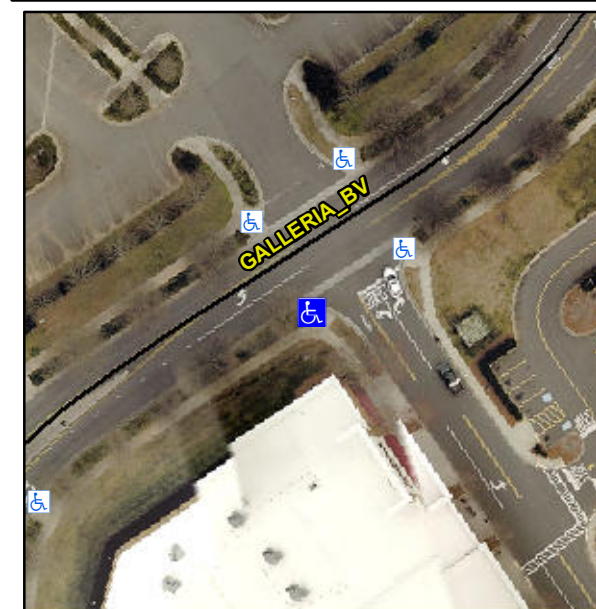
Not Found, R304.5.1

Compliance	Description	Data	Compliance	Description	Data
N/A	Ramp Length (in)	98.0	Yes	Ramp Slope (%)	6.3
No	Ramp Width (in)	28.5	Yes	Ramp XSlope (%)	1.6
N/A	Flare Type LT	N/A	N/A	Flare Type RT	N/A
N/A	Flare Slope LT (%)	N/A	N/A	Flare Slope RT (%)	N/A
N/A	Flare Traversable LT?	N/A	N/A	Flare Traversable RT?	N/A
N/A	Landing Length (in)	N/A	N/A	DWS Provided?	N/A
N/A	Landing Width (in)	N/A	N/A	DWS Contrast?	N/A
N/A	Landing Slope (%)	N/A	N/A	DWS Length (in)	N/A
N/A	Landing X Slope (%)	N/A	N/A	DWS Full Width?	N/A
N/A	Landing Curb? (Y/N)	N/A	N/A	DWS Offset (in)	N/A
N/A	Shared Landing?	N/A			
N/A	Gutter Ponding?	N/A	N/A	Gutter Slope (%)	N/A
N/A	Gutter Lip Ht (in)	N/A	N/A	Gutter X Slope (%)	N/A
N/A	Painted X Walk1?	No	N/A	Painted X Walk2?	No
	X Walk 1 Direction	To NE		X Walk 2 Direction	To N
N/A	X Walk 1 Width (in)	N/A	N/A	X Walk 2 Width (in)	N/A
	X Walk 1 Slope (%)	1.5		X Walk 2 Slope (%)	1.8
	X Walk 1 X Slope (%)	1.0		X Walk 2 X Slope (%)	0.1

N/A	Ramp inside XWalk1?	N/A	N/A	Ramp inside XWalk2?	N/A
	Road Slope (%)	1.3	N/A	Clear Space?	N/A
	Road X Slope (%)	0.4	N/A	Clear Space to XWalk (in)	N/A
N/A	Any Obstructions?	N/A	N/A	Storm Grate/Utility Hazard?	N/A
	Obstruction Type			Storm Grate/Utility Type	
		N/A			N/A
			Yes	Surface Condition? (G/P)	Good

Remove & Replace Curb Ramp With Two New Directional Ramps or Equivalent.

Total Cost: \$ 3200.00
