Access Compliance Report

Public Rights-of-Way

(Curb Ramps)

Intersection ID: 11691	Main Street: E_18TH_ST	Cross Street: N_MCDOWELL_ST	Location: S
ADA ID: 5F19033B3B73	Ramp Type: Perp	Initial Pass/Fail: Fail	Overall Compliance: No
Severity Score: 85			
Codes/Mitigation Info/Possible Solution		Field Measurements/Component Compliance

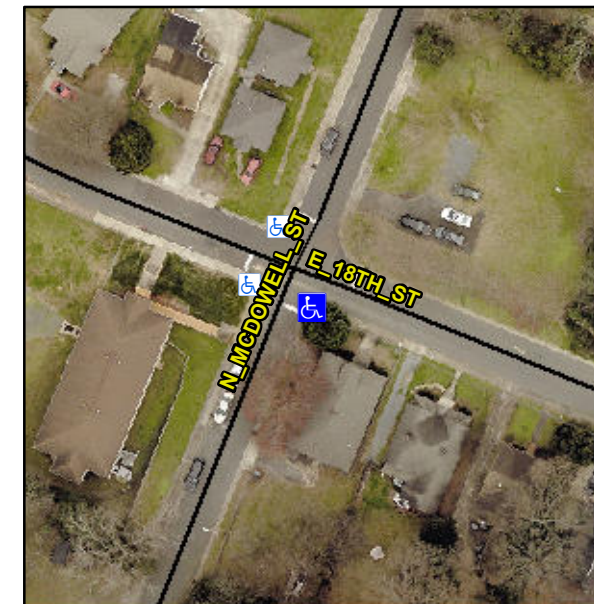
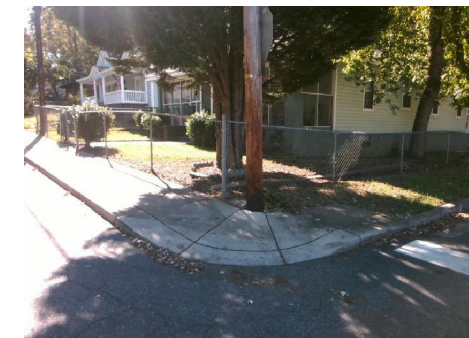
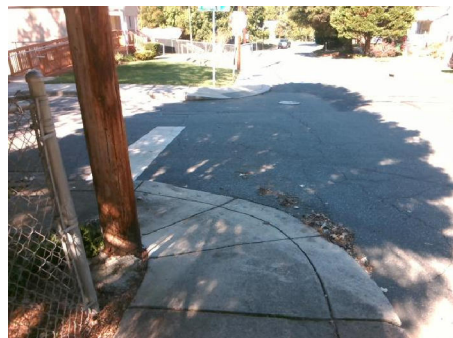
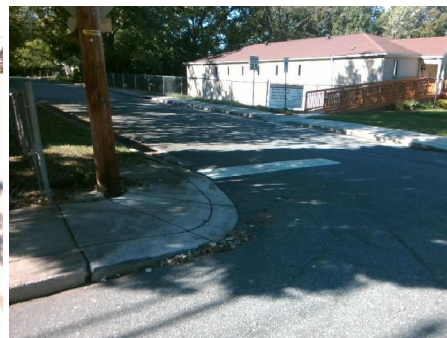
R304.5.1, R304.2.2, R304.5.3

Compliance	Description	Data	Compliance	Description	Data
N/A	Ramp Length (in)	56.5	No	Ramp Slope (%)	15.4
No	Ramp Width (in)	24.0	No	Ramp XSlope (%)	7.1
N/A	Flare Type LT	N/A	N/A	Flare Type RT	N/A
N/A	Flare Slope LT (%)	N/A	N/A	Flare Slope RT (%)	N/A
N/A	Flare Traversable LT?	N/A	N/A	Flare Traversable RT?	N/A
N/A	Landing Length (in)	N/A	N/A	DWS Provided?	N/A
N/A	Landing Width (in)	N/A	N/A	DWS Contrast?	N/A
N/A	Landing Slope (%)	N/A	N/A	DWS Length (in)	N/A
N/A	Landing X Slope (%)	N/A	N/A	DWS Full Width?	N/A
N/A	Landing Curb? (Y/N)	N/A	N/A	DWS Offset (in)	N/A
N/A	Shared Landing?	N/A			
N/A	Gutter Ponding?	N/A	N/A	Gutter Slope (%)	N/A
N/A	Gutter Lip Ht (in)	N/A	N/A	Gutter X Slope (%)	N/A
N/A	Painted X Walk1?	No	N/A	Painted X Walk2?	N/A
	X Walk 1 Direction	To NW		X Walk 2 Direction	N/A
N/A	X Walk 1 Width (in)	N/A	N/A	X Walk 2 Width (in)	N/A
	X Walk 1 Slope (%)	5.8		X Walk 2 Slope (%)	N/A
	X Walk 1 X Slope (%)	0.3		X Walk 2 X Slope (%)	N/A

N/A	Ramp inside XWalk1?	N/A	N/A	Ramp inside XWalk2?	N/A
	Road Slope (%)	N/A	N/A	Clear Space?	N/A
	Road X Slope (%)	N/A	N/A	Clear Space to XWalk (in)	N/A
N/A	Any Obstructions?	N/A	N/A	Storm Grate/Utility Hazard?	N/A
	Obstruction Type			Storm Grate/Utility Type	
		N/A			N/A
			Yes	Surface Condition? (G/P)	Good

Remove & Replace Entire Ramp.
