Access Compliance Report

Public Rights-of-Way (Curb Ramps)

Intersection ID: 10038833	Main Street: STEELECROFT_PY	Cross Street: N/A	Location: NW
ADA ID: 5F20B13B3788	Ramp Type: PerpDiag	Initial Pass/Fail: Fail	Overall Compliance: No
		Severity Score: 22.5

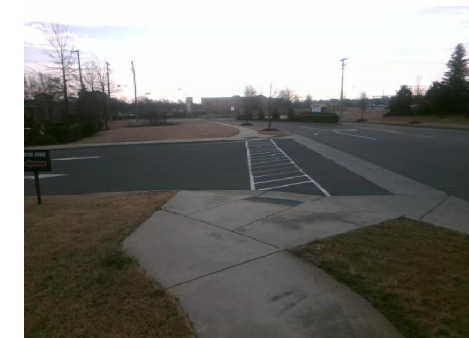
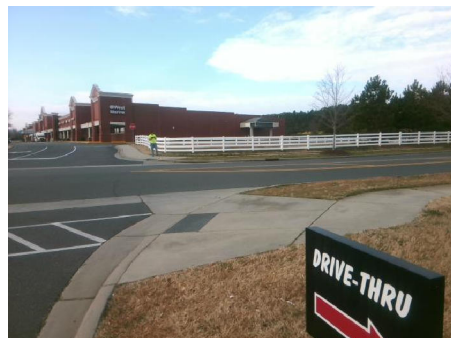
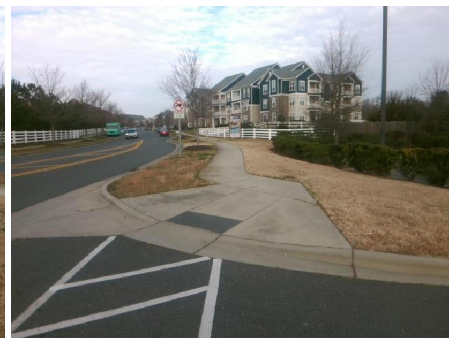
Compliance	Description	Data	Compliance	Description	Data
N/A	Ramp Length (in)	89.0	No	Ramp Slope (%)	10.5
No	Ramp Width (in)	45.0	No	Ramp XSlope (%)	4.3
N/A	Flare Type LT	N/A	N/A	Flare Type RT	N/A
N/A	Flare Slope LT (%)	N/A	N/A	Flare Slope RT (%)	N/A
N/A	Flare Traversable LT?	N/A	N/A	Flare Traversable RT?	N/A
N/A	Landing Length (in)	N/A	N/A	DWS Provided?	N/A
N/A	Landing Width (in)	N/A	N/A	DWS Contrast?	N/A
N/A	Landing Slope (%)	N/A	N/A	DWS Length (in)	N/A
N/A	Landing X Slope (%)	N/A	N/A	DWS Full Width?	N/A
N/A	Landing Curb? (Y/N)	N/A	N/A	DWS Offset (in)	N/A
N/A	Shared Landing?	N/A			
N/A	Gutter Ponding?	N/A	N/A	Gutter Slope (%)	N/A
N/A	Gutter Lip Ht (in)	N/A	N/A	Gutter X Slope (%)	N/A
N/A	Painted X Walk1?	No	N/A	Painted X Walk2?	Yes
	X Walk 1 Direction	To S		X Walk 2 Direction	To E
N/A	X Walk 1 Width (in)	N/A	N/A	X Walk 2 Width (in)	59.0
	X Walk 1 Slope (%)	1.2		X Walk 2 Slope (%)	1.6
	X Walk 1 X Slope (%)	1.5		X Walk 2 X Slope (%)	3.0

N/A	Ramp inside XWalk1?	N/A	N/A	Ramp inside XWalk2?	Yes
	Road Slope (%)	3.7	N/A	Clear Space?	N/A
	Road X Slope (%)	0.7	N/A	Clear Space to XWalk (in)	N/A
N/A	Any Obstructions?	N/A	N/A	Storm Grate/Utility Hazard?	N/A
	Obstruction Type			Storm Grate/Utility Type	
		N/A			N/A
			Yes	Surface Condition? (G/P)	Good

Remove & Replace Curb Ramp With Two New Directional Ramps or Equivalent.
