Intersection ID: 18818	Main Street: BEAM_RD	Cross Street: SHOPTON_RD	Location:	SW
ADA ID: 5F24C6DB28B5	Ramp Type: Perp	Initial Pass/Fail: Fail	Overall Compliance: No	Severity Score: 13.75

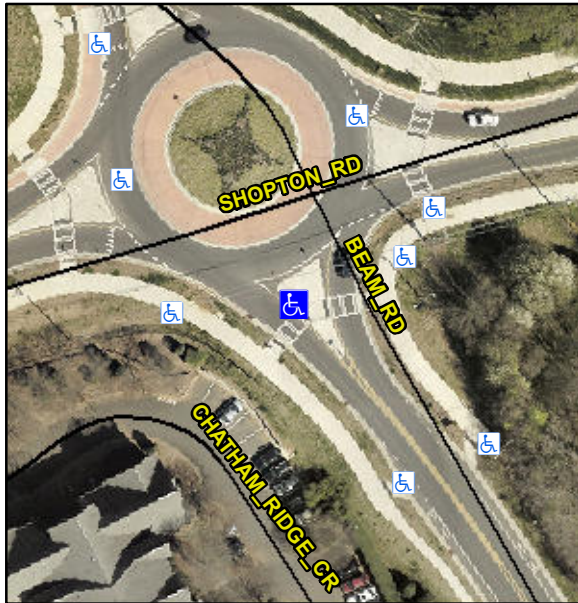
**R304.2.2, R304.5.3**

Possible Solutions:			Compliance	Description	Data	Compliance	Description	Data
Remove & Replace Entire Ramp.	N/A	Ramp Length (in)	96.0	No	Ramp Slope (%)	9.1		
	Yes	Ramp Width (in)	94.0	No	Ramp XSlope (%)	2.1		
	N/A	Flare Type LT	N/A	N/A	Flare Type RT	N/A		
	N/A	Flare Slope LT (%)	N/A	N/A	Flare Slope RT (%)	N/A		
	N/A	Flare Traversable LT?	N/A	N/A	Flare Traversable RT?	N/A		
	N/A	Landing Length (in)	N/A	N/A	DWS Provided?	N/A		
	N/A	Landing Width (in)	N/A	N/A	DWS Contrast?	N/A		
	N/A	Landing Slope (%)	N/A	N/A	DWS Length (in)	N/A		
	N/A	Landing X Slope (%)	N/A	N/A	DWS Full Width?	N/A		
	N/A	Landing Curb? (Y/N)	N/A	N/A	DWS Offset (in)	N/A		
	N/A	Shared Landing?	N/A					
	N/A	Gutter Ponding?	N/A	N/A	Gutter Slope (%)	N/A		
Surveyor Notes:  N/A	N/A	Gutter Lip Ht (in)	N/A	N/A	Gutter X Slope (%)	N/A		
	N/A	Painted X Walk1?	Yes	N/A	Painted X Walk2?	N/A		
		X Walk 1 Direction	To E		X Walk 2 Direction	N/A		
	N/A	X Walk 1 Width (in)	112.0	N/A	X Walk 2 Width (in)	N/A

X Walk 1 Slope (%)	0.2		X Walk 2 Slope (%)	N/A		
		X Walk 1 X Slope (%)	2.8		X Walk 2 X Slope (%)	N/A		
	N/A	Ramp inside XWalk1?	Yes	N/A	Ramp inside XWalk2?	N/A		
		Road Slope (%)	N/A	N/A	Clear Space?	N/A		
		Road X Slope (%)	N/A	N/A	Clear Space to XWalk (in)	N/A		
	N/A	Any Obstructions?	N/A	N/A	Storm Grate/Utility Hazard?	N/A		
		Obstruction Type			Storm Grate/Utility Type			
			N/A			N/A		
			Yes	Surface Condition? (G/P)	Good			
Total Cost:			\$	1850.00

### Remove & Replace Entire Ramp.
