# Access Compliance Report

## Public Rights-of-Way

### (Curb Ramps)

Intersection ID: 30005	Main Street: BACKWATER_DR	Cross Street: BRIGHTHAVEN_LN	Location: SW
ADA ID: 5F2779247F1E	Ramp Type: PerpDiag	Initial Pass/Fail: Fail	Overall Compliance: No
		Severity Score: 1.25

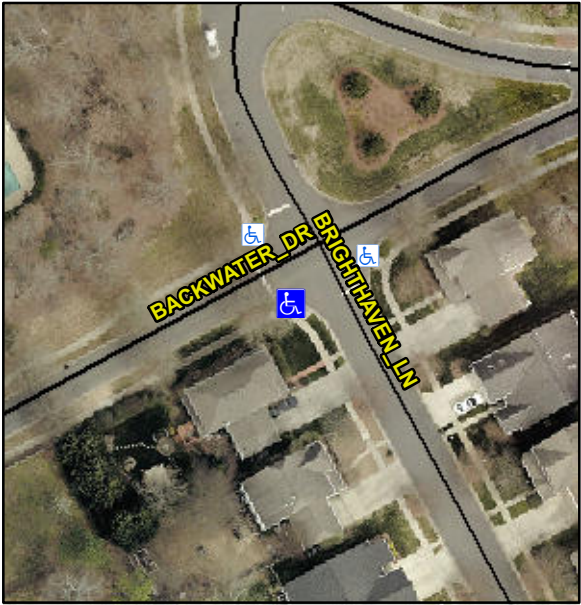
Possible Solutions:		<b>Compliance</b>	<b>Description</b>	<b>Data</b>
	<b>Remove &amp; Replace Curb Ramp With Two New Directional Ramps or Equivalent.</b>		<b>Yes</b>	Ramp Length (in)	<b>59.0</b>
			<b>N/A</b>	Ramp Width (in)	<b>48.0</b>
			<b>N/A</b>	Flare Type LT	<b>N/A</b>
			<b>N/A</b>	Flare Slope LT (%)	<b>N/A</b>
			<b>N/A</b>	Flare Traversable LT?	<b>N/A</b>
			<b>N/A</b>	Landing Length (in)	<b>N/A</b>
			<b>N/A</b>	Landing Width (in)	<b>N/A</b>
			<b>N/A</b>	Landing Slope (%)	<b>N/A</b>
			<b>N/A</b>	Landing X Slope (%)	<b>N/A</b>
<p>Surveyor Notes:</p> <p><b>N/A</b></p> <p>PROW/ADA:</p> <p><b>R304.5.3</b></p>			<b>N/A</b>	Flare Type RT	<b>N/A</b>
			<b>N/A</b>	Flare Slope RT (%)	<b>N/A</b>
			<b>N/A</b>	Flare Traversable RT?	<b>N/A</b>
			<b>N/A</b>	DWS Provided?	<b>N/A</b>
			<b>N/A</b>	DWS Contrast?	<b>N/A</b>

<b>N/A</b>	DWS Length (in)	<b>N/A</b>
			<b>N/A</b>	DWS Full Width?	<b>N/A</b>
			<b>N/A</b>	DWS Offset (in)	<b>N/A</b>
			<b>N/A</b>	Gutter Ponding?	<b>N/A</b>
			<b>N/A</b>	Gutter Lip Ht (in)	<b>N/A</b>
			<b>No</b>	Painted X Walk1?	<b>No</b>
			<b>To E</b>	X Walk 1 Direction	<b>To N</b>
			<b>N/A</b>	X Walk 1 Width (in)	<b>N/A</b>
			<b>5.6</b>	X Walk 1 Slope (%)	<b>4.7</b>
			<b>1.4</b>	X Walk 1 X Slope (%)	<b>5.0</b>
			<b>N/A</b>	Ramp inside XWalk1?	<b>N/A</b>
			<b>1.7</b>	Road Slope (%)	<b>N/A</b>
			<b>5.5</b>	Road X Slope (%)	<b>N/A</b>
			<b>N/A</b>	Any Obstructions?	<b>N/A</b>
			<b>N/A</b>	Obstruction Type	<b>N/A</b>
Total Cost:			<b>\$ 3200.00</b>		
			<b>N/A</b>	Clear Space?	<b>N/A</b>
			<b>N/A</b>	Clear Space to XWalk (in)	<b>N/A</b>
			<b>N/A</b>	Storm Grate/Utility Hazard?	<b>N/A</b>
			<b>N/A</b>	Storm Grate/Utility Type	<b>N/A</b>
			<b>Yes</b>	Surface Condition? (G/P)	<b>Good</b>
