Intersection ID: N/A	Main Street: MONROE_RD	Cross Street: N/A	Location:	SW
ADA ID: 5F341ED1456E	Ramp Type: Perp	Initial Pass/Fail: Fail	Overall Compliance: No	Severity Score: 13.75

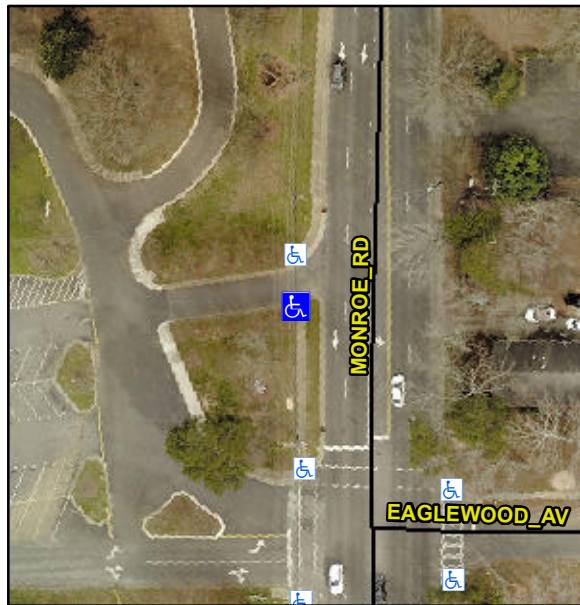
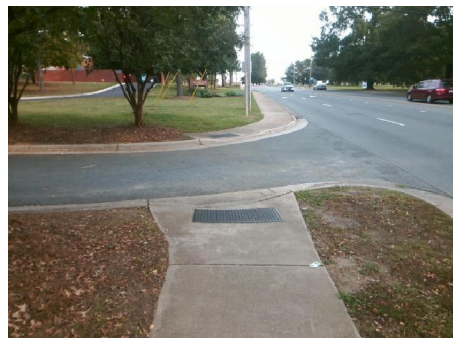
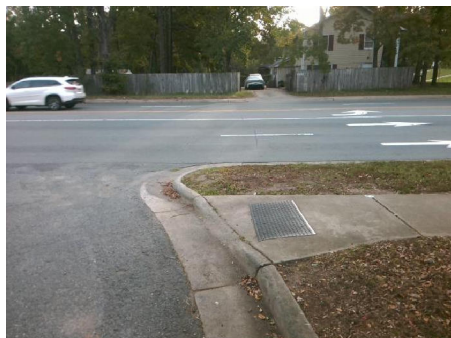
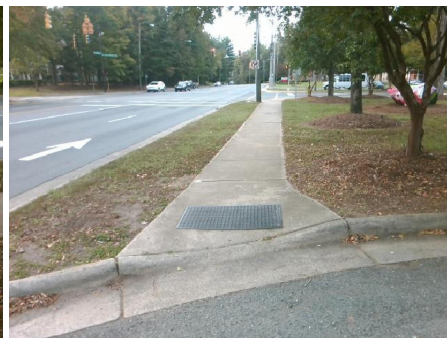
Not Found, R304.2.2

Possible Solutions:			Compliance	Description	Data	Compliance	Description	Data
Remove & Replace Entire Ramp.			N/A	Ramp Length (in)	73.0	No	Ramp Slope (%)	11.7
			Yes	Ramp Width (in)	48.0	Yes	Ramp XSlope (%)	2.3
			N/A	Flare Type LT	N/A	N/A	Flare Type RT	N/A
			N/A	Flare Slope LT (%)	N/A	N/A	Flare Slope RT (%)	N/A
			N/A	Flare Traversable LT?	N/A	N/A	Flare Traversable RT?	N/A
			N/A	Landing Length (in)	N/A	N/A	DWS Provided?	N/A
			N/A	Landing Width (in)	N/A	N/A	DWS Contrast?	N/A
			N/A	Landing Slope (%)	N/A	N/A	DWS Length (in)	N/A
			N/A	Landing X Slope (%)	N/A	N/A	DWS Full Width?	N/A
			N/A	Landing Curb? (Y/N)	N/A	N/A	DWS Offset (in)	N/A
Surveyor Notes: N/A			N/A	Shared Landing?	N/A			
			N/A	Gutter Ponding?	N/A	N/A	Gutter Slope (%)	N/A
			N/A	Gutter Lip Ht (in)	N/A	N/A	Gutter X Slope (%)	N/A
			N/A	Painted X Walk1?	No	N/A	Painted X Walk2?	N/A
				X Walk 1 Direction	To N		X Walk 2 Direction	N/A
			N/A	X Walk 1 Width (in)	N/A	N/A	X Walk 2 Width (in)	N/A

X Walk 1 Slope (%)	1.6		X Walk 2 Slope (%)	N/A
				X Walk 1 X Slope (%)	3.8		X Walk 2 X Slope (%)	N/A
			N/A	Ramp inside XWalk1?	N/A	N/A	Ramp inside XWalk2?	N/A
				Road Slope (%)	N/A	N/A	Clear Space?	N/A
PROW/ADA: Not Found, R304.2.2				Road X Slope (%)	N/A	N/A	Clear Space to XWalk (in)	N/A
			N/A	Any Obstructions?	N/A	N/A	Storm Grate/Utility Hazard?	N/A
				Obstruction Type			Storm Grate/Utility Type	
					N/A			N/A
						Yes	Surface Condition? (G/P)	Good
Total Cost:			\$	1850.00

Remove & Replace Entire Ramp.
