Access Compliance Report

Public Rights-of-Way

(Curb Ramps)

Intersection ID: 12863	Main Street: E_3RD_ST	Cross Street: S_CALDWELL_ST	Location: NW
ADA ID: 5F365A4BDE21	Ramp Type: Perp	Initial Pass/Fail: Fail	Overall Compliance: No
Severity Score: 13.75			
Codes/Mitigation Info/Possible Solution		Field Measurements/Component Compliance

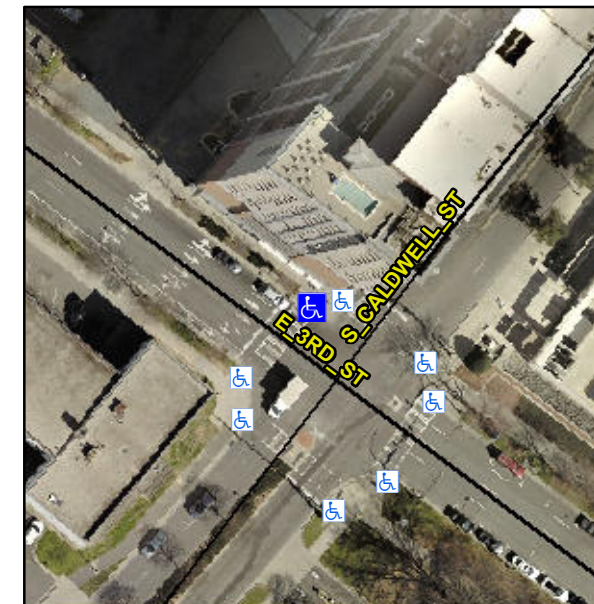
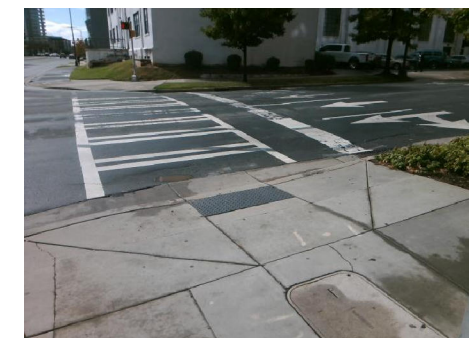
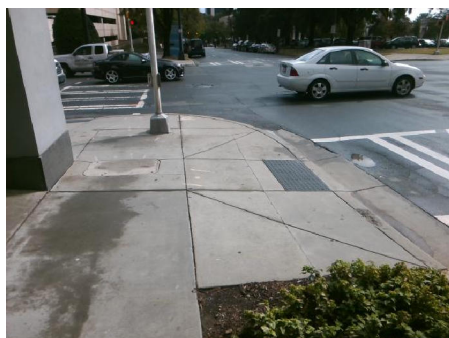
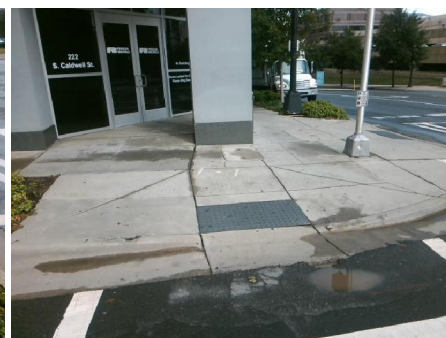
Not Found, R304.2.2, R304.5.3

Compliance	Description	Data	Compliance	Description	Data
N/A	Ramp Length (in)	72.0	No	Ramp Slope (%)	8.9
Yes	Ramp Width (in)	48.0	No	Ramp XSlope (%)	2.9
N/A	Flare Type LT	N/A	N/A	Flare Type RT	N/A
N/A	Flare Slope LT (%)	N/A	N/A	Flare Slope RT (%)	N/A
N/A	Flare Traversable LT?	N/A	N/A	Flare Traversable RT?	N/A
N/A	Landing Length (in)	N/A	N/A	DWS Provided?	N/A
N/A	Landing Width (in)	N/A	N/A	DWS Contrast?	N/A
N/A	Landing Slope (%)	N/A	N/A	DWS Length (in)	N/A
N/A	Landing X Slope (%)	N/A	N/A	DWS Full Width?	N/A
N/A	Landing Curb? (Y/N)	N/A	N/A	DWS Offset (in)	N/A
N/A	Shared Landing?	N/A			
N/A	Gutter Ponding?	N/A	N/A	Gutter Slope (%)	N/A
N/A	Gutter Lip Ht (in)	N/A	N/A	Gutter X Slope (%)	N/A
N/A	Painted X Walk1?	Yes	N/A	Painted X Walk2?	N/A
	X Walk 1 Direction	To SW		X Walk 2 Direction	N/A
N/A	X Walk 1 Width (in)	115.0	N/A	X Walk 2 Width (in)	N/A
	X Walk 1 Slope (%)	3.8		X Walk 2 Slope (%)	N/A
	X Walk 1 X Slope (%)	1.7		X Walk 2 X Slope (%)	N/A

N/A	Ramp inside XWalk1?	Yes	N/A	Ramp inside XWalk2?	N/A
	Road Slope (%)	N/A	N/A	Clear Space?	N/A
	Road X Slope (%)	N/A	N/A	Clear Space to XWalk (in)	N/A
N/A	Any Obstructions?	N/A	N/A	Storm Grate/Utility Hazard?	N/A
	Obstruction Type			Storm Grate/Utility Type	
		N/A			N/A
		Yes		Surface Condition? (G/P)	Good

Possible Solutions:

Remove & Replace Entire Ramp.
