# Access Compliance Report

## Public Rights-of-Way

### (Curb Ramps)

Intersection ID: 20823	Main Street: CROWN CENTRE DR	Cross Street: TOWER POINT DR	Location: E
ADA ID: 5F43394EC8EA	Ramp Type: PerpDiag	Initial Pass/Fail: Fail	Overall Compliance: No
Severity Score: 33.75			
Codes/Mitigation Info/Possible Solution		Field Measurements/Component Compliance

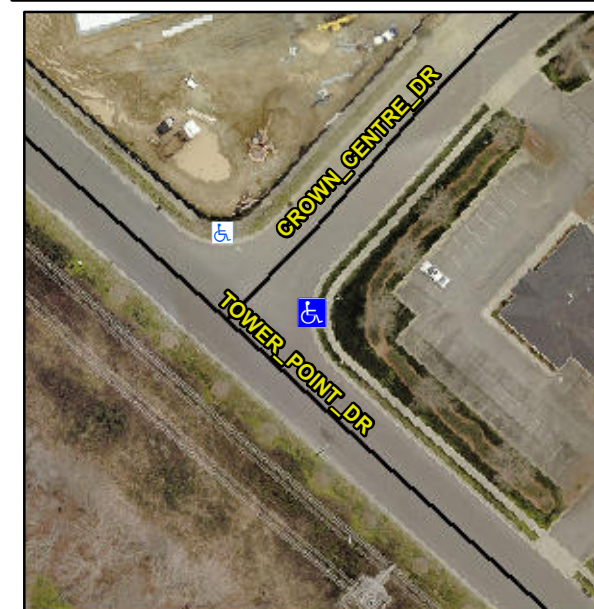
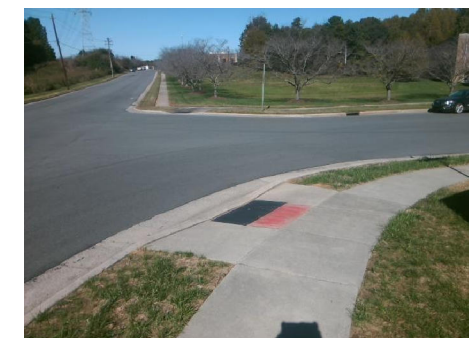
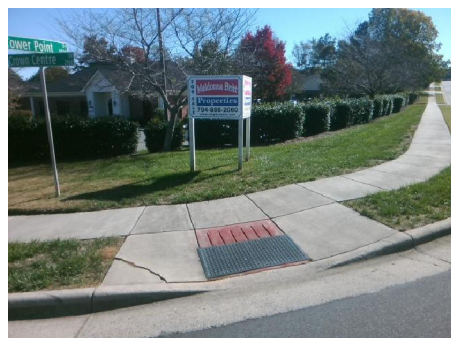
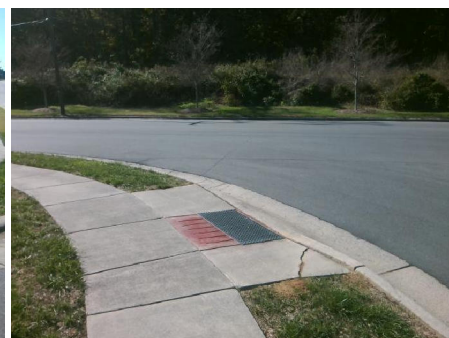
**R304.5.1, R304.2.2, R304.5.3**

Compliance	Description	Data	Compliance	Description	Data
N/A	Ramp Length (in)	48.0	No	Ramp Slope (%)	10.2
No	Ramp Width (in)	43.0	No	Ramp XSlope (%)	6.4
N/A	Flare Type LT	N/A	N/A	Flare Type RT	N/A
N/A	Flare Slope LT (%)	N/A	N/A	Flare Slope RT (%)	N/A
N/A	Flare Traversable LT?	N/A	N/A	Flare Traversable RT?	N/A
N/A	Landing Length (in)	N/A	N/A	DWS Provided?	N/A
N/A	Landing Width (in)	N/A	N/A	DWS Contrast?	N/A
N/A	Landing Slope (%)	N/A	N/A	DWS Length (in)	N/A
N/A	Landing X Slope (%)	N/A	N/A	DWS Full Width?	N/A
N/A	Landing Curb? (Y/N)	N/A	N/A	DWS Offset (in)	N/A
N/A	Shared Landing?	N/A			
N/A	Gutter Ponding?	N/A	N/A	Gutter Slope (%)	N/A
N/A	Gutter Lip Ht (in)	N/A	N/A	Gutter X Slope (%)	N/A
N/A	Painted X Walk1?	No	N/A	Painted X Walk2?	No
	X Walk 1 Direction	To NW		X Walk 2 Direction	To SW
N/A	X Walk 1 Width (in)	N/A	N/A	X Walk 2 Width (in)	N/A
	X Walk 1 Slope (%)	2.5		X Walk 2 Slope (%)	7.4
	X Walk 1 X Slope (%)	6.3		X Walk 2 X Slope (%)	4.2

N/A	Ramp inside XWalk1?	N/A	N/A	Ramp inside XWalk2?	N/A
	Road Slope (%)	4.7	N/A	Clear Space?	N/A
	Road X Slope (%)	4.2	N/A	Clear Space to XWalk (in)	N/A
N/A	Any Obstructions?	N/A	N/A	Storm Grate/Utility Hazard?	N/A
	Obstruction Type			Storm Grate/Utility Type	
		N/A			N/A
			Yes	Surface Condition? (G/P)	Good

**Remove & Replace Curb Ramp With Two New Directional Ramps or Equivalent.**
