Access Compliance Report Public Rights-of-Way (Curb Ramps)

Intersection ID: 15869 Main Street: MARSH RD **Cross Street: SEDGEFIELD RD** Location: ADA ID: 5F4FC38452C0 Ramp Type: PerpDiag Initial Pass/Fail: Fail **Overall Compliance: No** Severity Score: 13.75

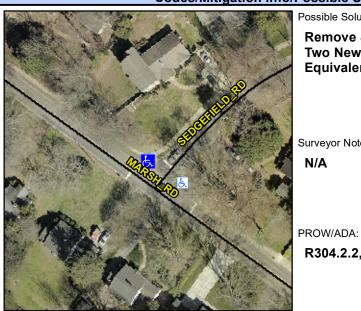
Compliance Description		Data	Compliance		Description	Data
N/A	Ramp Length (in)	64.0	No	Ramp	Slope (%)	8.4
Yes	Ramp Width (in)	48.0	No	Ramp	XSlope (%)	2.8
N/A	Flare Type LT	N/A	N/A	Flare	Type RT	N/A
N/A	Flare Slope LT (%)	N/A	N/A	Flare	Slope RT (%)	N/A
N/A	Flare Traversable LT?	N/A	N/A	Flare	Traversable RT?	N/A
N/A	Landing Length (in)	N/A	N/A	DWS	Provided?	N/A
N/A	Landing Width (in)	N/A	N/A	DWS	Contrast?	N/A
N/A	Landing Slope (%)	N/A	N/A	DWS	Length (in)	N/A
N/A	Landing X Slope (%)	N/A	N/A	DWS	Full Width?	N/A
N/A	Landing Curb? (Y/N)	N/A	N/A	DWS	Offset (in)	N/A
N/A	Shared Landing?	N/A				
N/A	Gutter Ponding?	N/A	N/A	Gutte	r Slope (%)	N/A
N/A	Gutter Lip Ht (in)	N/A	N/A	Gutte	er X Slope (%)	N/A
N/A	Painted X Walk1?	No	N/A	Paint	ed X Walk2?	No
	X Walk 1 Direction	To SW		X Wa	lk 2 Direction	To SE
N/A	X Walk 1 Width (in)	N/A	N/A	X Wa	lk 2 Width (in)	N/A
	X Walk 1 Slope (%)	2.0		X Wa	lk 2 Slope (%)	2.6
	X Walk 1 X Slope (%)	0.4		X Wa	lk 2 X Slope (%)	0.8

N/A	Ramp inside XWalk1?	N/A	N/A	Ram	inside XWalk2?	N/A
	Road Slope (%)	1.9	N/A	Clear	Space?	N/A
	Road X Slope (%)	3.3	N/A	Clear	Space to XWalk (in)	N/A
N/A	Any Obstructions?	N/A	N/A	Storn	n Grate/Utility Hazard?	N/A
	Obstruction Type		l	Storn	n Grate/Utility Type	
		N/A				N/A

MARSH RD StopSign Possible Solutions: **Remove & Replace Curb Ramp With** Two New Directional Ramps or Equivalent.

R304.2.2, R304.5.3

> Total Cost: 3200.00
