Access Compliance Report

Public Rights-of-Way

(Curb Ramps)

| Intersection ID: 50940 | Main Street: BLAIRBETH_ST | Cross Street: ARDREY_KELL_RD | Location: NE |

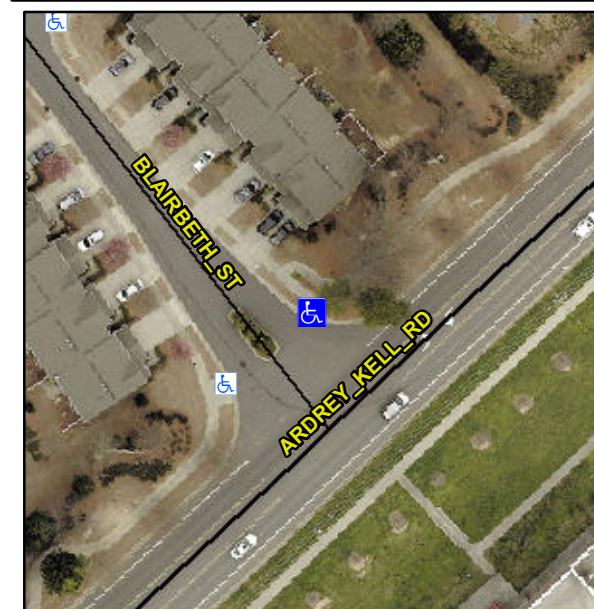
| ADA ID: 5F5016D9254A | Ramp Type: Perp | Initial Pass/Fail: Fail | Overall Compliance: No |
| Severity Score: 12.5 | | | |

Not Found, R304.2.2

| Compliance | Description | Data | Compliance | Description | Data |
|---|---|---|---|---|---|
| N/A | Ramp Length (in) | 93.0 | No | Ramp Slope (%) | 10.3 |
| Yes | Ramp Width (in) | 48.0 | Yes | Ramp XSlope (%) | 1.1 |
| | | | Yes | Surface Condition? (G/P) | Good |

Possible Solutions:

Remove & Replace Entire Ramp.

Total Cost: \$ 1850.00
