| Intersection ID: 11879 | Main Street: AIRLIE_ST | Cross Street: ELLEN_AV | Location: | NE |
| ADA ID: 5F53F578B04F | Ramp Type: Perp | Initial Pass/Fail: Fail | Overall Compliance: No | Severity Score: 12.5 |

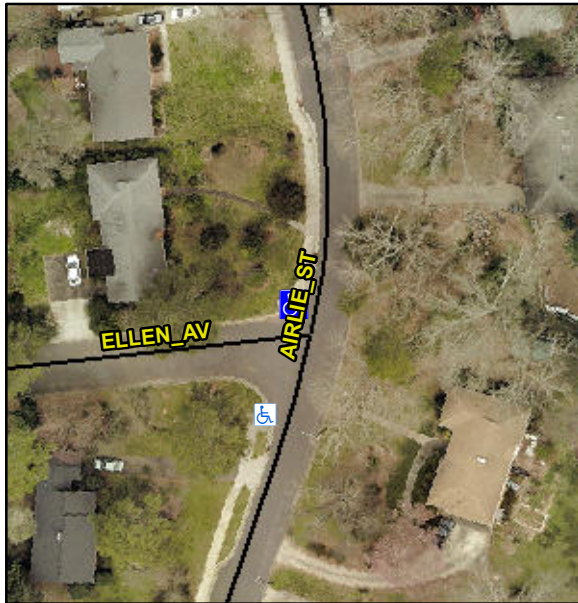
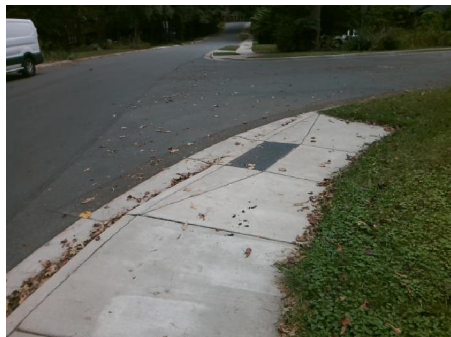
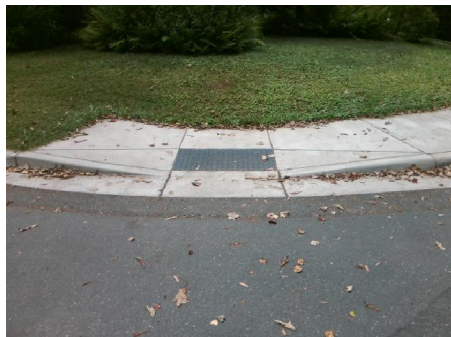
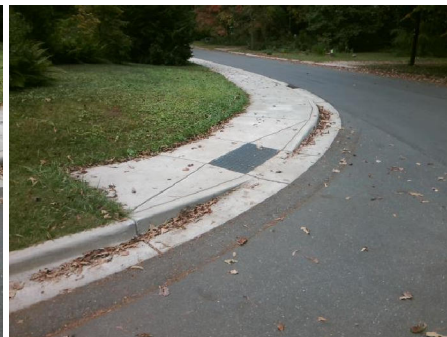
**Not Found, R304.2.2**

| Compliance | Description | Data | Compliance | Description | Data |
|---|---|---|---|---|---|
| N/A | Ramp Length (in) | 60.0 | No | Ramp Slope (%) | 9.6 |
| Yes | Ramp Width (in) | 48.0 | Yes | Ramp XSlope (%) | 0.2 |

### Remove & Replace Entire Ramp.
