Access Compliance Report

Public Rights-of-Way

(Curb Ramps)

Intersection ID: 10021845	Main Street: BRIXHAM_HILL_AV	Cross Street: N/A	Location: NW
ADA ID: 5F5DCBBA2275	Ramp Type: Perp	Initial Pass/Fail: Fail	Overall Compliance: No
Severity Score: 12.5			
Codes/Mitigation Info/Possible Solution		Field Measurements/Component Compliance

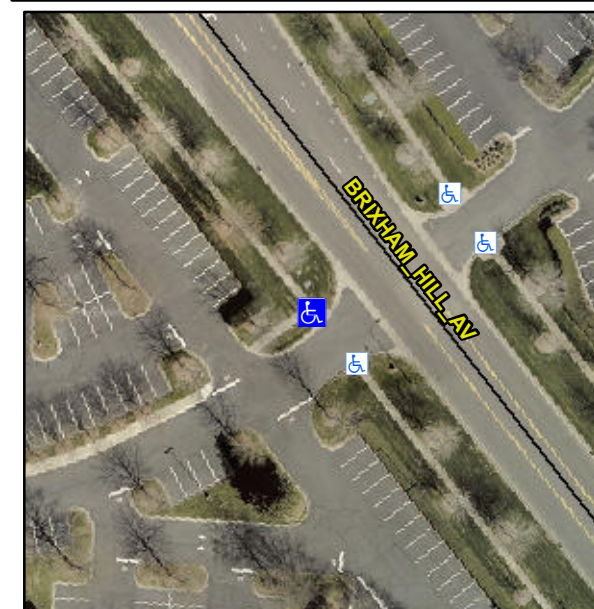
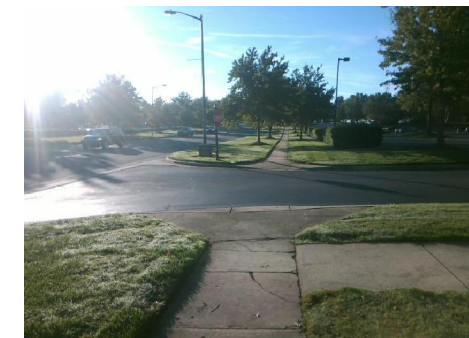
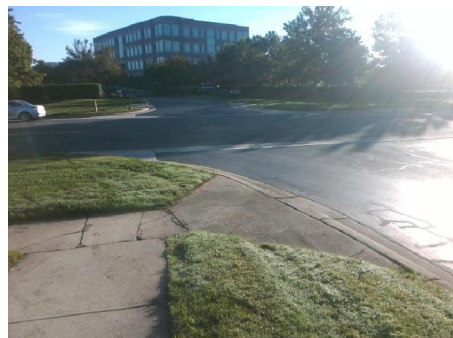
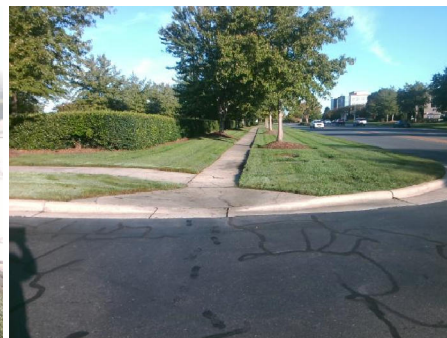
PROW/ADA:

R304.5.3

Compliance	Description	Data	Compliance	Description	Data
N/A	Ramp Length (in)	72.0	Yes	Ramp Slope (%)	7.2
Yes	Ramp Width (in)	48.0	No	Ramp XSlope (%)	5.4
N/A	Flare Type LT	N/A	N/A	Flare Type RT	N/A
N/A	Flare Slope LT (%)	N/A	N/A	Flare Slope RT (%)	N/A
N/A	Flare Traversable LT?	N/A	N/A	Flare Traversable RT?	N/A
N/A	Landing Length (in)	N/A	N/A	DWS Provided?	N/A
N/A	Landing Width (in)	N/A	N/A	DWS Contrast?	N/A
N/A	Landing Slope (%)	N/A	N/A	DWS Length (in)	N/A
N/A	Landing X Slope (%)	N/A	N/A	DWS Full Width?	N/A
N/A	Landing Curb? (Y/N)	N/A	N/A	DWS Offset (in)	N/A
N/A	Shared Landing?	N/A			
N/A	Gutter Ponding?	N/A	N/A	Gutter Slope (%)	N/A
N/A	Gutter Lip Ht (in)	N/A	N/A	Gutter X Slope (%)	N/A
N/A	Painted X Walk1?	No	N/A	Painted X Walk2?	N/A
	X Walk 1 Direction	To SE		X Walk 2 Direction	N/A
N/A	X Walk 1 Width (in)	N/A	N/A	X Walk 2 Width (in)	N/A
	X Walk 1 Slope (%)	3.1		X Walk 2 Slope (%)	N/A
	X Walk 1 X Slope (%)	2.8		X Walk 2 X Slope (%)	N/A

N/A	Ramp inside XWalk1?	N/A	N/A	Ramp inside XWalk2?	N/A
	Road Slope (%)	N/A	N/A	Clear Space?	N/A
	Road X Slope (%)	N/A	N/A	Clear Space to XWalk (in)	N/A
N/A	Any Obstructions?	N/A	N/A	Storm Grate/Utility Hazard?	N/A
	Obstruction Type			Storm Grate/Utility Type	
		N/A			N/A
			Yes	Surface Condition? (G/P)	Good

Possible Solutions:

Remove & Replace Entire Ramp.

Total Cost:

\$ 1850.00
