# Access Compliance Report

## Public Rights-of-Way

### (Curb Ramps)

Intersection ID: 42950	Main Street: BENZIGER_CT	Cross Street: LONG_PAW_LN	Location: SW
ADA ID: 5F675D4DA526	Ramp Type: Perp	Initial Pass/Fail: Fail	Overall Compliance: No
Severity Score: 8.75			
Codes/Mitigation Info/Possible Solution		Field Measurements/Component Compliance

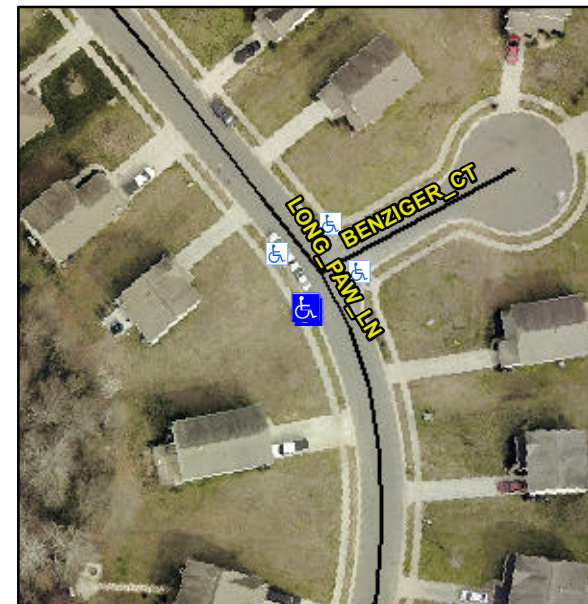
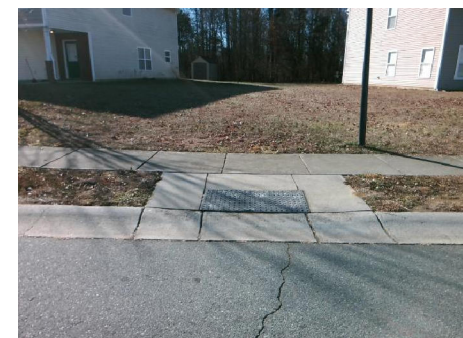
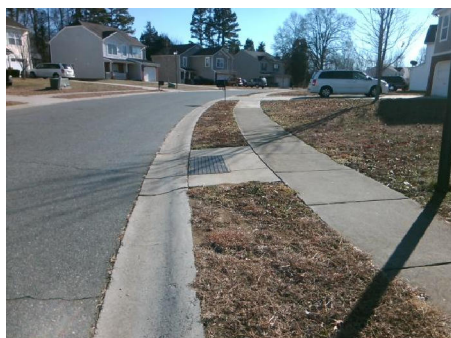
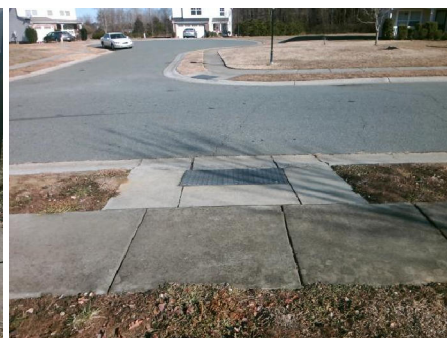
**Not Found, R304.5.1**

Compliance	Description	Data	Compliance	Description	Data
N/A	Ramp Length (in)	48.0	Yes	Ramp Slope (%)	8.0
No	Ramp Width (in)	47.0	Yes	Ramp XSlope (%)	1.5
N/A	Flare Type LT	N/A	N/A	Flare Type RT	N/A
N/A	Flare Slope LT (%)	N/A	N/A	Flare Slope RT (%)	N/A
N/A	Flare Traversable LT?	N/A	N/A	Flare Traversable RT?	N/A
N/A	Landing Length (in)	N/A	N/A	DWS Provided?	N/A
N/A	Landing Width (in)	N/A	N/A	DWS Contrast?	N/A
N/A	Landing Slope (%)	N/A	N/A	DWS Length (in)	N/A
N/A	Landing X Slope (%)	N/A	N/A	DWS Full Width?	N/A
N/A	Landing Curb? (Y/N)	N/A	N/A	DWS Offset (in)	N/A
N/A	Shared Landing?	N/A			
N/A	Gutter Ponding?	N/A	N/A	Gutter Slope (%)	N/A
N/A	Gutter Lip Ht (in)	N/A	N/A	Gutter X Slope (%)	N/A
N/A	Painted X Walk1?	No	N/A	Painted X Walk2?	N/A
	X Walk 1 Direction	To E		X Walk 2 Direction	N/A
N/A	X Walk 1 Width (in)	N/A	N/A	X Walk 2 Width (in)	N/A
	X Walk 1 Slope (%)	3.4		X Walk 2 Slope (%)	N/A
	X Walk 1 X Slope (%)	1.6		X Walk 2 X Slope (%)	N/A

N/A	Ramp inside XWalk1?	N/A	N/A	Ramp inside XWalk2?	N/A
	Road Slope (%)	N/A	N/A	Clear Space?	N/A
	Road X Slope (%)	N/A	N/A	Clear Space to XWalk (in)	N/A
N/A	Any Obstructions?	N/A	N/A	Storm Grate/Utility Hazard?	N/A
	Obstruction Type			Storm Grate/Utility Type	
		N/A			N/A
			Yes	Surface Condition? (G/P)	Good

**Remove & Replace Entire Ramp.**

Total Cost: \$ 1850.00
