# Access Compliance Report

## Public Rights-of-Way

### (Curb Ramps)

| Intersection ID: 18963 | Main Street: GROVER_RD | Cross Street: SOUTH_BV | Location: SE |

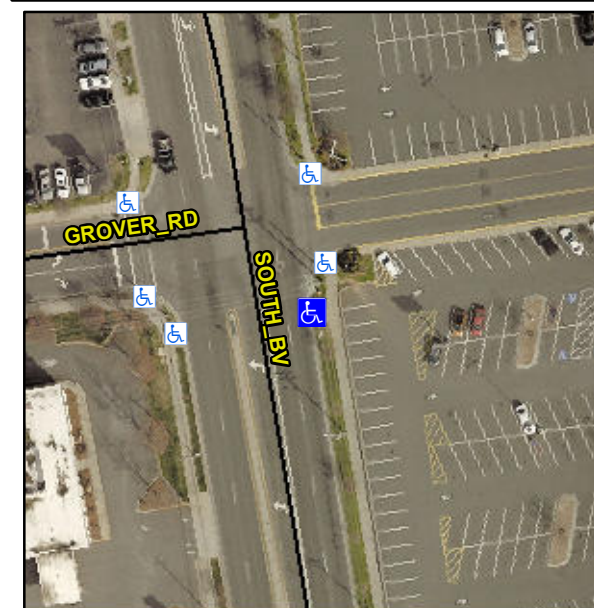
**Not Found, R304.2.2**

| Compliance | Description | Data | Compliance | Description | Data |
|---|---|---|---|---|---|
| N/A | Ramp Length (in) | 92.0 | No | Ramp Slope (%) | 9.2 |

Possible Solutions:

**Remove & Replace Entire Ramp.**

Total Cost: \$ 1850.00

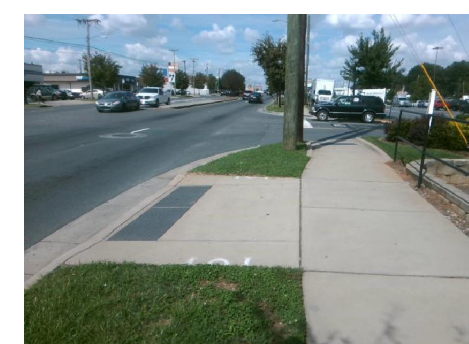
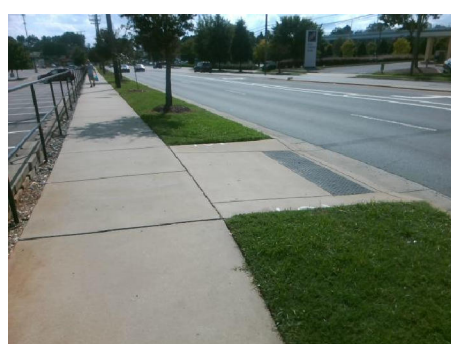
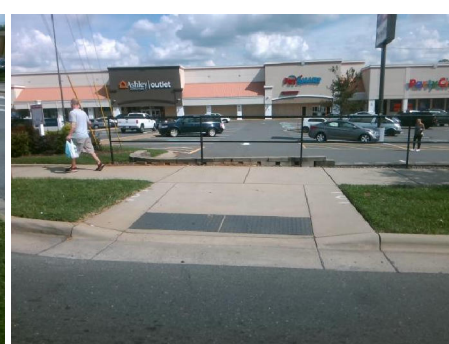
| Compliance | Description | Data | Compliance | Description | Data |
|---|---|---|---|---|---|
| Yes | Ramp Width (in) | 96.0 | Yes | Ramp XSlope (%) | 1.7 |
