Intersection ID: 29377	Main Street: BUCKVALLEY_DR	Cross Street: EULER_WY	Location:	NW
ADA ID: 5F6AA6D5621A	Ramp Type: PerpDiag	Initial Pass/Fail: Fail	Overall Compliance: No	Severity Score: 8.75

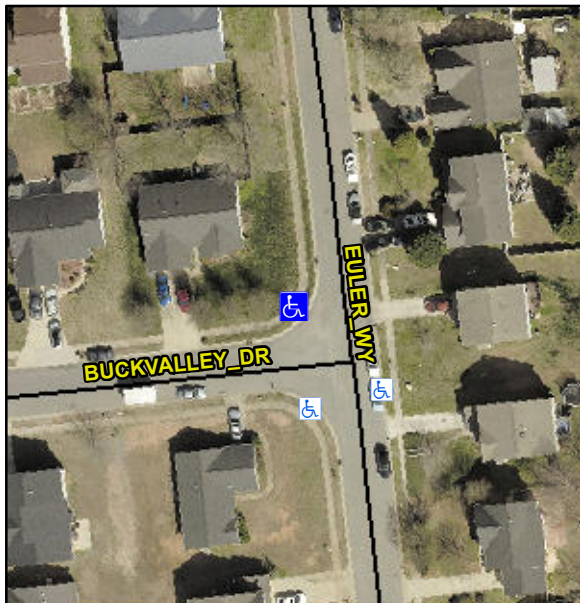
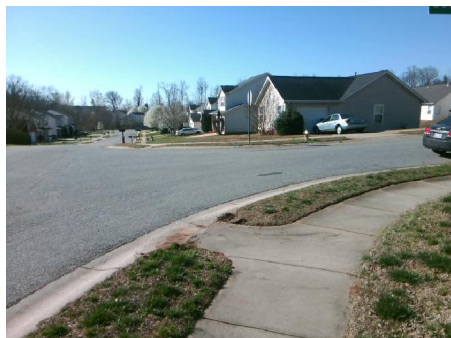
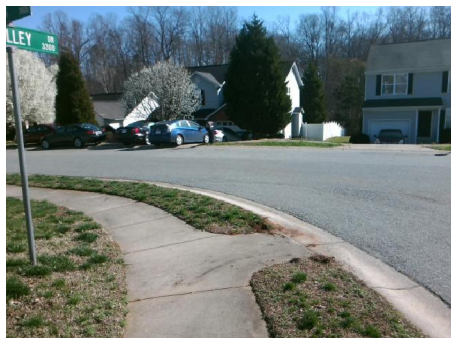
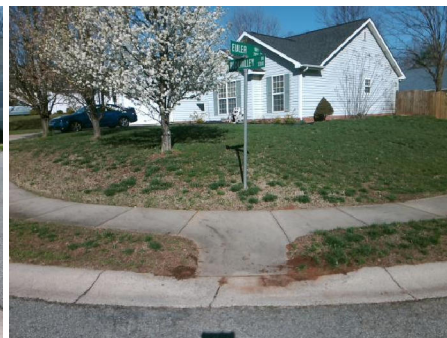
N/A	Landing X Slope (%)			N/A	N/A	DWS Full Width?			N/A
N/A	Landing Curb? (Y/N)			N/A	N/A	DWS Offset (in)			N/A
N/A	Shared Landing?			N/A					
N/A	Gutter Ponding?			N/A	N/A	Gutter Slope (%)			N/A
N/A	Gutter Lip Ht (in)			N/A	N/A	Gutter X Slope (%)			N/A
N/A	Painted X Walk1?			No	N/A	Painted X Walk2?			No
	X Walk 1 Direction			To S		X Walk 2 Direction			To E
N/A	X Walk 1 Width (in)			N/A	N/A	X Walk 2 Width (in)			N/A
	X Walk 1 Slope (%)			1.2		X Walk 2 Slope (%)			0.2
	X Walk 1 X Slope (%)			2.5		X Walk 2 X Slope (%)			0.3
N/A	Ramp inside XWalk1?			N/A	N/A	Ramp inside XWalk2?			N/A
	Road Slope (%)			2.0	N/A	Clear Space?			N/A
	Road X Slope (%)			3.8	N/A	Clear Space to XWalk (in)			N/A
N/A	Any Obstructions?			N/A	N/A	Storm Grate/Utility Hazard?			N/A
	Obstruction Type					Storm Grate/Utility Type			
				N/A					N/A
					Yes	Surface Condition? (G/P)			Good

Possible Solutions:			Remove & Replace Curb Ramp With Two New Directional Ramps or Equivalent.					
	Surveyor Notes:			N/A					
	PROW/ADA:			R304.5.1					
	Street 1 Name			BUCKVALLEY DR					
	Stop Condition-Street 2			StopSign					
	Street 2 Name			EULER WY					
	Stop Condition-Street 1			None					
	Total Cost:			\$ 3200.00					
Compliance		Description		Data	Compliance		Description		Data
N/A	Ramp Length (in)			94.5	Yes	Ramp Slope (%)			5.1
No	Ramp Width (in)			47.0	Yes	Ramp XSlope (%)			0.1
N/A	Flare Type LT			N/A	N/A	Flare Type RT			N/A
N/A	Flare Slope LT (%)			N/A	N/A	Flare Slope RT (%)			N/A
N/A	Flare Traversable LT?			N/A	N/A	Flare Traversable RT?			N/A
N/A	Landing Length (in)			N/A	N/A	DWS Provided?			N/A
N/A	Landing Width (in)			N/A	N/A	DWS Contrast?			N/A
N/A	Landing Slope (%)			N/A	N/A	DWS Length (in)			N/A
