Access Compliance Report

Public Rights-of-Way

(Curb Ramps)

Intersection ID: 27530	Main Street: BALLANTYNE_COMMONS_PY	Cross Street: BALLANTYNE_FOREST_DR	Location: NE
ADA ID: 5F70736128FE	Ramp Type: Perp	Initial Pass/Fail: Fail	Overall Compliance: No
Severity Score: 8.75			
Codes/Mitigation Info/Possible Solution		Field Measurements/Component Compliance

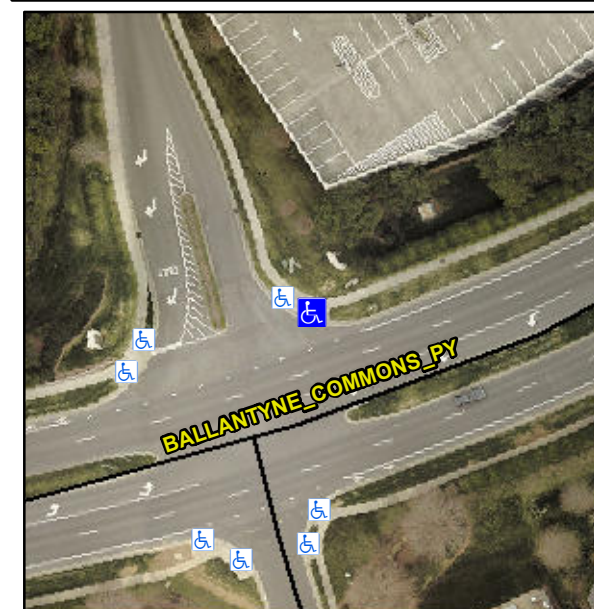
Not Found, R304.5.1

Compliance	Description	Data	Compliance	Description	Data
N/A	Ramp Length (in)	129.5	Yes	Ramp Slope (%)	7.3
No	Ramp Width (in)	46.5	Yes	Ramp XSlope (%)	1.3
N/A	Flare Type LT	N/A	N/A	Flare Type RT	N/A
N/A	Flare Slope LT (%)	N/A	N/A	Flare Slope RT (%)	N/A
N/A	Flare Traversable LT?	N/A	N/A	Flare Traversable RT?	N/A
N/A	Landing Length (in)	N/A	N/A	DWS Provided?	N/A
N/A	Landing Width (in)	N/A	N/A	DWS Contrast?	N/A
N/A	Landing Slope (%)	N/A	N/A	DWS Length (in)	N/A
N/A	Landing X Slope (%)	N/A	N/A	DWS Full Width?	N/A
N/A	Landing Curb? (Y/N)	N/A	N/A	DWS Offset (in)	N/A
N/A	Shared Landing?	N/A			
N/A	Gutter Ponding?	N/A	N/A	Gutter Slope (%)	N/A
N/A	Gutter Lip Ht (in)	N/A	N/A	Gutter X Slope (%)	N/A
N/A	Painted X Walk1?	No	N/A	Painted X Walk2?	N/A
	X Walk 1 Direction	To S		X Walk 2 Direction	N/A
N/A	X Walk 1 Width (in)	N/A	N/A	X Walk 2 Width (in)	N/A
	X Walk 1 Slope (%)	3.7		X Walk 2 Slope (%)	N/A
	X Walk 1 X Slope (%)	1.4		X Walk 2 X Slope (%)	N/A

N/A	Ramp inside XWalk1?	N/A	N/A	Ramp inside XWalk2?	N/A
	Road Slope (%)	N/A	N/A	Clear Space?	N/A
	Road X Slope (%)	N/A	N/A	Clear Space to XWalk (in)	N/A
N/A	Any Obstructions?	N/A	N/A	Storm Grate/Utility Hazard?	N/A
	Obstruction Type			Storm Grate/Utility Type	
		N/A			N/A
			Yes	Surface Condition? (G/P)	Good

Possible Solutions:

Remove & Replace Entire Ramp.
