Access Compliance Report

Public Rights-of-Way

(Curb Ramps)

Intersection ID: 11096	Main Street: AVENTIDE_LN	Cross Street: CAMP_STEWART_RD	Location: SE
ADA ID: 5F7C6620C6D0	Ramp Type: Perp	Initial Pass/Fail: Fail	Overall Compliance: No
Severity Score: 33.75			
Codes/Mitigation Info/Possible Solution		Field Measurements/Component Compliance

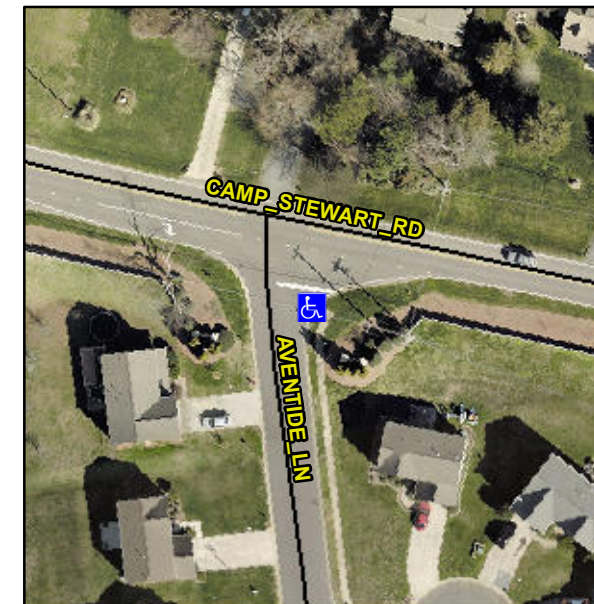
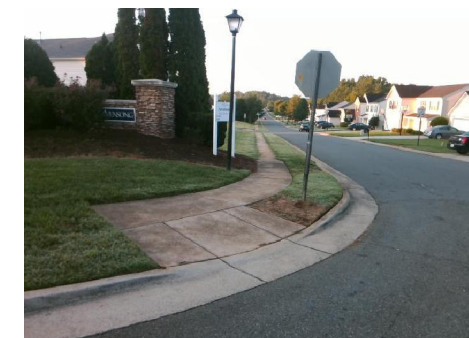
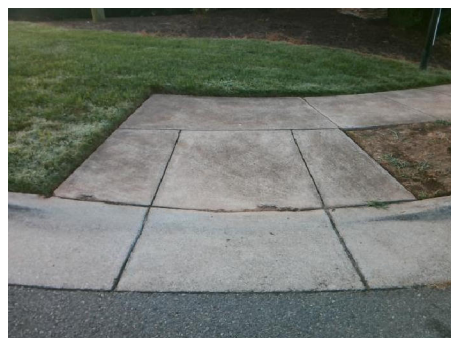
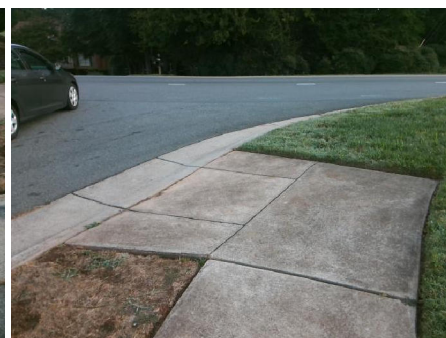
Not Found, R304.5.1, R304.2.2, R304.5.3

Compliance	Description	Data	Compliance	Description	Data
N/A	Ramp Length (in)	50.0	No	Ramp Slope (%)	9.9
No	Ramp Width (in)	43.0	No	Ramp XSlope (%)	5.2
N/A	Flare Type LT	N/A	N/A	Flare Type RT	N/A
N/A	Flare Slope LT (%)	N/A	N/A	Flare Slope RT (%)	N/A
N/A	Flare Traversable LT?	N/A	N/A	Flare Traversable RT?	N/A
N/A	Landing Length (in)	N/A	N/A	DWS Provided?	N/A
N/A	Landing Width (in)	N/A	N/A	DWS Contrast?	N/A
N/A	Landing Slope (%)	N/A	N/A	DWS Length (in)	N/A
N/A	Landing X Slope (%)	N/A	N/A	DWS Full Width?	N/A
N/A	Landing Curb? (Y/N)	N/A	N/A	DWS Offset (in)	N/A
N/A	Shared Landing?	N/A			
N/A	Gutter Ponding?	N/A	N/A	Gutter Slope (%)	N/A
N/A	Gutter Lip Ht (in)	N/A	N/A	Gutter X Slope (%)	N/A
N/A	Painted X Walk1?	No	N/A	Painted X Walk2?	N/A
	X Walk 1 Direction	To NW		X Walk 2 Direction	N/A
N/A	X Walk 1 Width (in)	N/A	N/A	X Walk 2 Width (in)	N/A
	X Walk 1 Slope (%)	2.7		X Walk 2 Slope (%)	N/A
	X Walk 1 X Slope (%)	5.6		X Walk 2 X Slope (%)	N/A

N/A	Ramp inside XWalk1?	N/A	N/A	Ramp inside XWalk2?	N/A
	Road Slope (%)	5.6	N/A	Clear Space?	N/A
	Road X Slope (%)	2.7	N/A	Clear Space to XWalk (in)	N/A
N/A	Any Obstructions?	N/A	N/A	Storm Grate/Utility Hazard?	N/A
	Obstruction Type			Storm Grate/Utility Type	
		N/A			N/A
			Yes	Surface Condition? (G/P)	Good

Possible Solutions:

Remove & Replace Entire Ramp.
