# Access Compliance Report

## Public Rights-of-Way

### (Curb Ramps)

| Intersection ID: 15207 | Main Street: WINFIELD_DR | Cross Street: WOODLAND_DR | Location: SE |

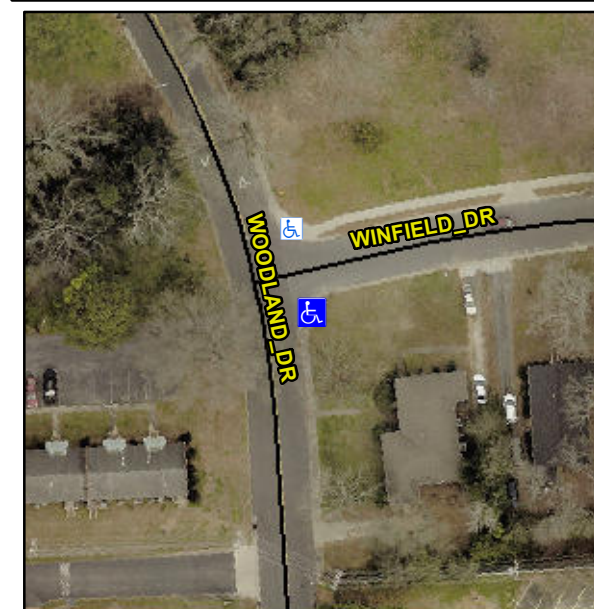
**R304.2.2, R304.5.3**

| Compliance | Description | Data | Compliance | Description | Data |
|---|---|---|---|---|---|
| N/A | Ramp Length (in) | 55.0 | No | Ramp Slope (%) | 11.5 |
| Yes | Ramp Width (in) | 64.0 | No | Ramp XSlope (%) | 2.7 |

**Remove & Replace Entire Ramp.**

Total Cost: \$ 1850.00
