Access Compliance Report

Public Rights-of-Way

(Curb Ramps)

Intersection ID: 10019157	Main Street: TIPPAH_PARK_CT	Cross Street: N/A	Location:	E
ADA ID: 5F8EECC8C858	Ramp Type: Perp	Initial Pass/Fail: Fail	Overall Compliance: No	Severity Score: 25

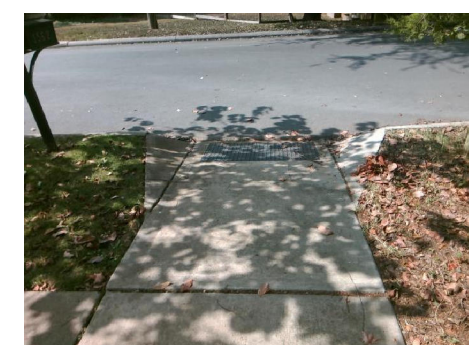
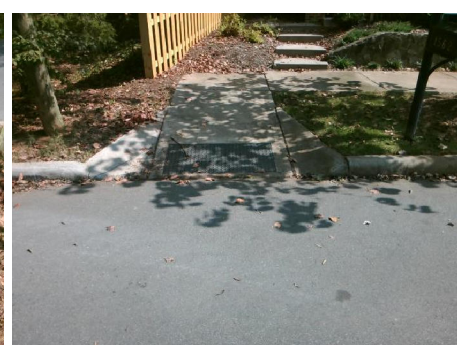
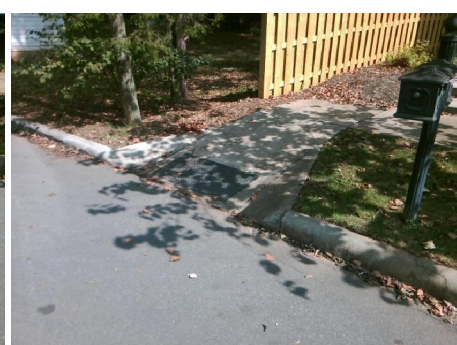
Possible Solutions:		Compliance	Description	Data
	Remove & Replace Entire Ramp.		No	Ramp Length (in)	18.5
			Yes	Ramp Width (in)	0.5
			N/A	Flare Type LT	N/A
			N/A	Flare Slope LT (%)	N/A
			N/A	Flare Traversable LT?	N/A
			N/A	Landing Length (in)	N/A
			N/A	Landing Width (in)	N/A
			N/A	Landing Slope (%)	N/A
			N/A	Landing X Slope (%)	N/A
<p>Surveyor Notes:</p> <p>N/A</p> <p>PROW/ADA:</p> <p>R304.2.2</p>			N/A	Flare Type RT	N/A
			N/A	Flare Slope RT (%)	N/A
			N/A	Flare Traversable RT?	N/A
			N/A	DWS Provided?	N/A
			N/A	DWS Contrast?	N/A
			N/A	DWS Length (in)	N/A
			N/A	DWS Full Width?	N/A
			N/A	DWS Offset (in)	N/A
			N/A	Shared Landing?	N/A
			N/A	Gutter Ponding?	N/A
			N/A	Gutter Lip Ht (in)	N/A
			No	Painted X Walk1?	N/A
			To W	X Walk 1 Direction	N/A
			N/A	X Walk 1 Width (in)	N/A

0.9	X Walk 1 Slope (%)	N/A
			1.1	X Walk 1 X Slope (%)	N/A
			N/A	Ramp inside XWalk1?	N/A
			1.1	Road Slope (%)	N/A
			0.9	Road X Slope (%)	N/A
			N/A	Any Obstructions?	N/A
			N/A	Obstruction Type	N/A
			N/A	Clear Space?	N/A
			N/A	Clear Space to XWalk (in)	N/A
			N/A	Storm Grate/Utility Hazard?	N/A
			N/A	Storm Grate/Utility Type	N/A
			N/A	Surface Condition? (G/P)	Good
Total Cost:		\$ 1850.00
