# Access Compliance Report

## Public Rights-of-Way

### (Curb Ramps)

| Intersection ID: 7065 | Main Street: EBARA_LN | Cross Street: KINGVILLE_DR | Location: SE |

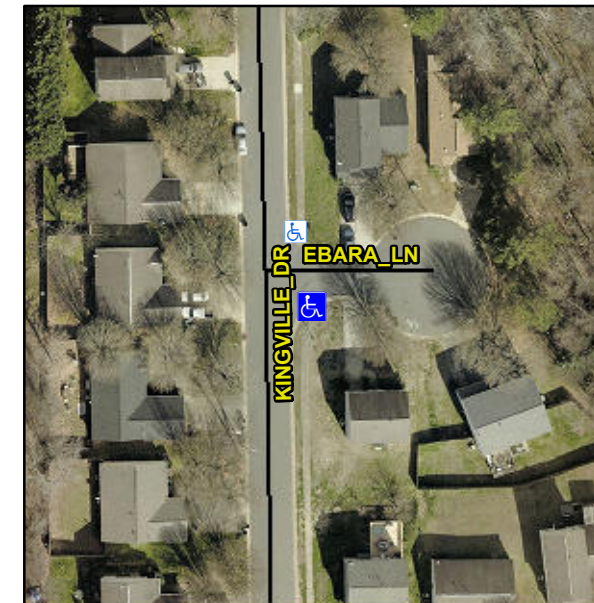
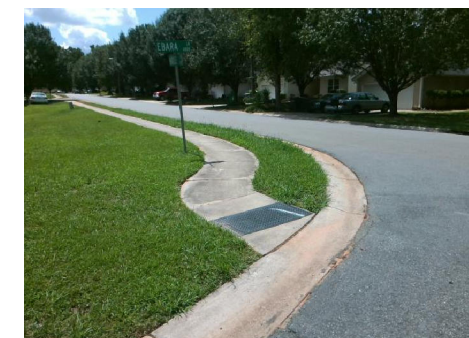
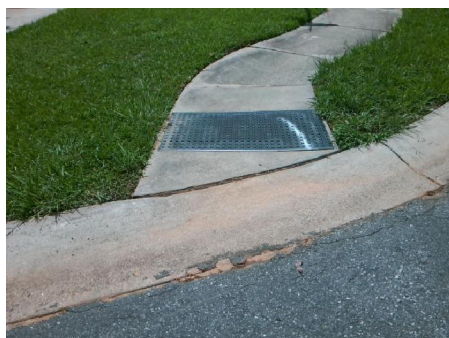
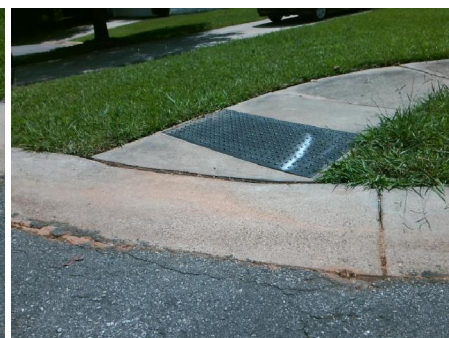
**CURB GAP 1.0**

**Not Found, R304.2.1, R304.2.2-Perp,  
R304.3.2-Para, R304.5.3, R305.1.4,  
R302.7.2**

| Compliance | Description | Data | Compliance | Description | Data |
|---|---|---|---|---|---|
| Yes | Ramp Width (in) | 49.0 | No | Grade Break Slope (%) | 6.1 |
| No | Landing Length (in) | 30.0 | Yes | DWS Provided? | Yes |
| No | Landing Slope (%) | 6.4 | Yes | DWS Length (in) | 25.5 |
| No | Landing X Slope (%) | 2.2 | No | DWS Full Width? | No |
| No | Gutter Lip Ht (in) | 0.5 | No | Gutter X Slope (%) | 3.9 |

**Remove & Replace Entire Ramp.  
Remove & Replace Gutter.**
