Access Compliance Report

Public Rights-of-Way

(Curb Ramps)

Intersection ID: 14567	Main Street: E_TREMONT_AV	Cross Street: LYNDHURST_AV	Location: E
ADA ID: 5FAF93A7F677	Ramp Type: BlendTrans1	Initial Pass/Fail: Fail	Overall Compliance: No
			Severity Score: 21.25

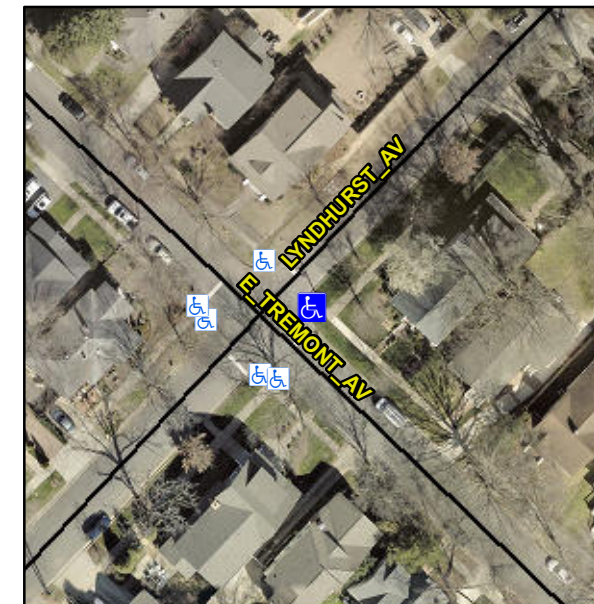
Compliance	Description	Data	Compliance	Description	Data
N/A	Ramp Length (in)	28.0	Yes	BlendTrans Slope (%)	1.4
No	Ramp Width (in)	45.0	No	BlendTrans XSlope (%)	5.5
N/A	Flare Type LT	N/A	N/A	Flare Type RT	N/A
N/A	Flare Slope LT (%)	N/A	N/A	Flare Slope RT (%)	N/A
N/A	Flare Traversable LT?	N/A	N/A	Flare Traversable RT?	N/A
N/A	Landing Length (in)	N/A	N/A	DWS Provided?	N/A
N/A	Landing Width (in)	N/A	N/A	DWS Contrast?	N/A
N/A	Landing Slope (%)	N/A	N/A	DWS Length (in)	N/A
N/A	Landing X Slope (%)	N/A	N/A	DWS Full Width?	N/A
N/A	Landing Curb? (Y/N)	N/A	N/A	DWS Offset (in)	N/A
N/A	Shared Landing?	N/A			
N/A	Gutter Ponding?	N/A	N/A	Gutter Slope (%)	N/A
N/A	Gutter Lip Ht (in)	1.0	N/A	Gutter X Slope (%)	N/A
N/A	Painted X Walk1?	No	N/A	Painted X Walk2?	No
	X Walk 1 Direction	To NW		X Walk 2 Direction	To SW
	X Walk 1 Width (in)	N/A		X Walk 2 Width (in)	N/A
	X Walk 1 Slope (%)	8.1		X Walk 2 Slope (%)	2.8
	X Walk 1 X Slope (%)	0.4		X Walk 2 X Slope (%)	3.7

N/A	Ramp inside XWalk1?	N/A	N/A	Ramp inside XWalk2?	N/A
	Road Slope (%)	2.8		Clear Space?	N/A
	Road X Slope (%)	4.5	N/A	Clear Space to XWalk (in)	N/A
N/A	Any Obstructions?	N/A	N/A	Storm Grate/Utility Hazard?	N/A
	Obstruction Type			Storm Grate/Utility Type	
		N/A			N/A
			Yes	Surface Condition? (G/P)	Good
			N/A	Curb Slope (%)	1.6

Remove & Replace Curb Ramp With Two New Directional Ramps or Equivalent.

R304.5.1, R304.5.3
