## Access Compliance Report Public Rights-of-Way (Curb Ramps)

Intersection ID: 10037058 Main Street: S TRYON ST Cross Street: N/A							Location	SE	
	Main Street: S_TRYON_ST			Cross Street: N/A				Location:	
ADA ID: 5FC3F7E98EDD	E98EDD Ramp Type: PerpDiag			Initial Pass/Fail: Fail Overall Compliance: No				o Severity Score:	33.75
Codes/Mitigation Info/Possible Solution				Field Measurements/Component Compliance					
State	P	Possible Solutions:		Compliance Description			Data Compliance Description		Data
	12 "	Remove & Replace Curb Ram	p With	N/A	Ramp Length (in)	57.0	No	Ramp Slope (%)	8.6
	11	Two New Directional Ramps or Equivalent.	r	No	Ramp Width (in)	46.0	No	Ramp XSlope (%)	5.6
	91			N/A	Flare Type LT	N/A	N/A	Flare Type RT	N/A
	21/1			N/A	Flare Slope LT (%)	N/A	N/A	Flare Slope RT (%)	N/A
				N/A	Flare Traversable LT?	N/A	N/A	Flare Traversable RT?	N/A
				N/A	Landing Length (in)	N/A	N/A	DWS Provided?	N/A
	s s	urveyor Notes:		N/A	Landing Width (in)	N/A	N/A	DWS Contrast?	N/A

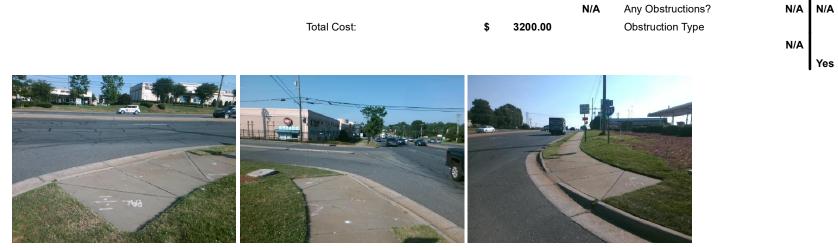
11.41	N/A		N/A	Landing Slope (%)	N/A	N/A	DWS Length (in)	N/A
				N/A	Landing X Slope (%)	N/A	N/A	DWS Full Width?	N/A
ATTALY AND COM	· · · // ~			N/A	Landing Curb? (Y/N)	N/A	N/A	DWS Offset (in)	N/A
E C				N/A	Shared Landing?	N/A

1.	P	ROW/ADA:		N/A	Gutter Ponding?	N/A	N/A	Gutter Slope (%)	N/A
	Nega .	Not Found, R304.5.1, R304.2.	304.2.2,	N/A	Gutter Lip Ht (in)	N/A	N/A	Gutter X Slope (%)	N/A
		R304.5.3		N/A	Painted X Walk1?	No	N/A	Painted X Walk2?	No
A Shirt to the states	1				X Walk 1 Direction	To N		X Walk 2 Direction	To S
	and the second			N/A	X Walk 1 Width (in)	N/A	N/A	X Walk 2 Width (in)	N/A
Street 1 Name	S TRYON ST				X Walk 1 Slope (%)	2.4		X Walk 2 Slope (%)	2.7
Stop Condition-Street 2	None				X Walk 1 X Slope (%)	3.2		X Walk 2 X Slope (%)	1.6
Street 2 Name	ENTRANCE			N/A	Ramp inside XWalk1?	N/A	N/A	Ramp inside XWalk2?	N/A
Stop Condition-Street 1	None				Road Slope (%)	3.9	N/A	Clear Space?	N/A
					Road X Slope (%)	0.2	N/A	Clear Space to XWalk (in)	N/A
				N/A	Any Obstructions?	N/A	N/A	Storm Grate/Utility Hazard?	N/A
	То	otal Cost: \$	3200.00		Obstruction Type			Storm Grate/Utility Type	
						N/A			N/A

s Surface Condition? (G/P)

Good
