Access Compliance Report

Public Rights-of-Way

(Curb Ramps)

| Intersection ID: 18083 | Main Street: DELLWOOD_AV | Cross Street: HILLSDALE_AV | Location: NW |

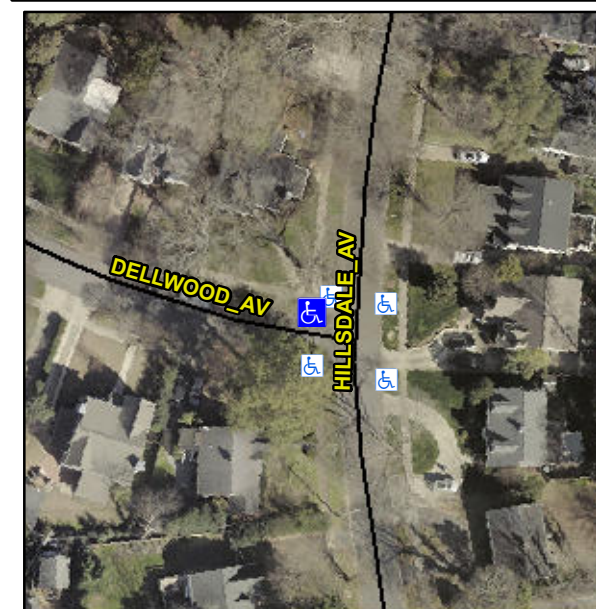
| ADA ID: 5FF682DC978C | Ramp Type: Perp | Initial Pass/Fail: Fail | Overall Compliance: No |
| Severity Score: 50 | | | |

Not Found, R304.2.2, R304.5.3

| Compliance | Description | Data | Compliance | Description | Data |
|---|---|---|---|---|---|
| N/A | Ramp Length (in) | 100.0 | No | Ramp Slope (%) | 14.3 |
| Yes | Ramp Width (in) | 50.0 | No | Ramp XSlope (%) | 11.2 |

Possible Solutions:

Remove & Replace Entire Ramp.
