# Access Compliance Report

## Public Rights-of-Way

### (Curb Ramps)

| Intersection ID: 10023727 | Main Street: COLISEUM_CENTRE_DR | Cross Street: N/A | Location: S |

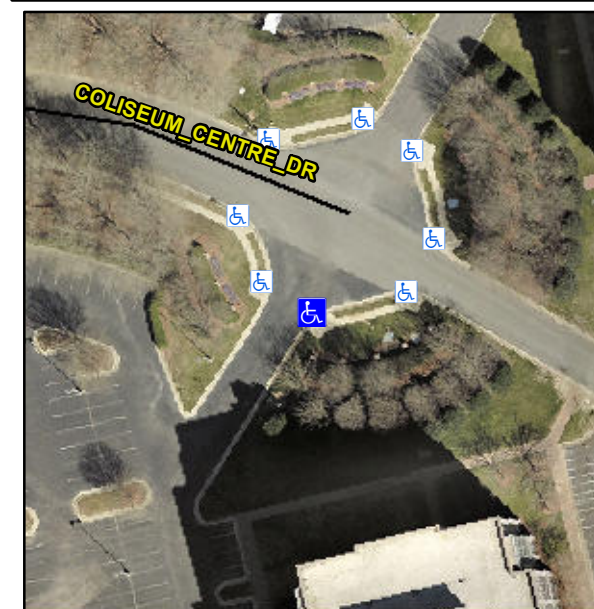
| ADA ID: 600AE74BC830 | Ramp Type: Perp | Initial Pass/Fail: Fail | Overall Compliance: No |
| Severity Score: 18.75 | | | |

**R304.5.1, R304.5.3**

| Compliance | Description | Data | Compliance | Description | Data |
|---|---|---|---|---|---|
| N/A | Ramp Length (in) | 97.0 | Yes | Ramp Slope (%) | 6.0 |
| No | Ramp Width (in) | 34.0 | No | Ramp XSlope (%) | 5.0 |

**Remove & Replace Entire Ramp.**

Total Cost: \$ 1850.00
