## **Access Compliance Report Public Rights-of-Way** (Curb Ramps)

Intersection ID: 10026324 Main Street: FAIRVIEW RD **Cross Street: N/A** Location: SW Initial Pass/Fail: Fail **ADA ID: 600D8E8D59CE** Ramp Type: PerpDiag **Overall Compliance: No Severity Score:** 65

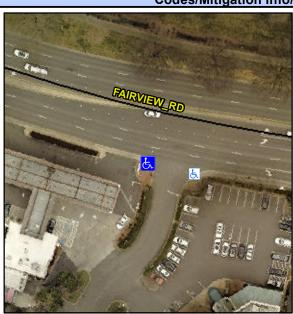
Field Measurements/Component Compliance						
	Compliance Description		Data	Comp	oliance Description	Data
	N/A	Ramp Length (in)	37.0	No	Ramp Slope (%)	14.9
	Yes	Ramp Width (in)	48.0	No	Ramp XSlope (%)	8.3
	N/A	Flare Type LT	N/A	N/A	Flare Type RT	N/A
	N/A	Flare Slope LT (%)	N/A	N/A	Flare Slope RT (%)	N/A
	N/A	Flare Traversable LT?	N/A	N/A	Flare Traversable RT?	N/A
	N/A	Landing Length (in)	N/A	N/A	DWS Provided?	N/A
	N/A	Landing Width (in)	N/A	N/A	DWS Contrast?	N/A
	N/A	Landing Slope (%)	N/A	N/A	DWS Length (in)	N/A
	N/A	Landing X Slope (%)	N/A	N/A	DWS Full Width?	N/A
	N/A	Landing Curb? (Y/N)	N/A	N/A	DWS Offset (in)	N/A
	N/A	Shared Landing?	N/A			
	N/A	Gutter Ponding?	N/A	N/A	Gutter Slope (%)	N/A
	N/A	Gutter Lip Ht (in)	N/A	N/A	Gutter X Slope (%)	N/A
	N/A	Painted X Walk1?	No	N/A	Painted X Walk2?	No
		X Walk 1 Direction	To SE		X Walk 2 Direction	To NE
	N/A	X Walk 1 Width (in)	N/A	N/A	X Walk 2 Width (in)	N/A
		X Walk 1 Slope (%)	2.6		X Walk 2 Slope (%)	0.3

X Walk 1 X Slope (%)	1.4		X Walk 2 X Slope (%)	8.0
	N/A	Ramp inside XWalk1?	N/A	N/A	Ramp inside XWalk2?	N/A
		Road Slope (%)	0.5	N/A	Clear Space?	N/A
		Road X Slope (%)	1.3	N/A	Clear Space to XWalk (in)	N/A
	N/A	Any Obstructions?	N/A	N/A	Storm Grate/Utility Hazard?	N/A
		Obstruction Type			Storm Grate/Utility Type	
			N/A			N/A
				No	Surface Condition? (G/P)	Poor
1

Possible Solutions: **Remove & Replace Curb Ramp With Two New Directional Ramps or** Equivalent. Surveyor Notes: N/A PROW/ADA: R304.2.2, R304.5.3, R302.7
